Refurbishing Outlet Valves utilising Shutdown Periods

Frank Nitzsche

GHD, Sydney, Australia

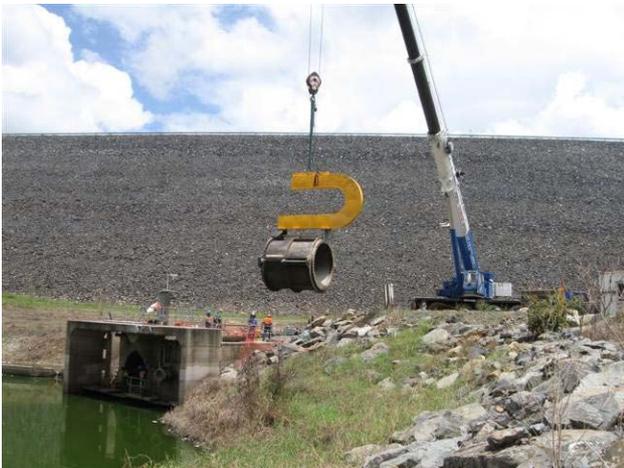
Figure 3: DN 1900 cone valve removal

- High rainfall filled the dam to overflowing in a matter of days. The large flow over the spillway resulted in high tail water levels, flooding the river discharge pit and delaying the removal of the DN 2000 butterfly valve and DN 1900 cone valve by 3 weeks. A coffer dam was eventually constructed to allow removal of the cone valve.

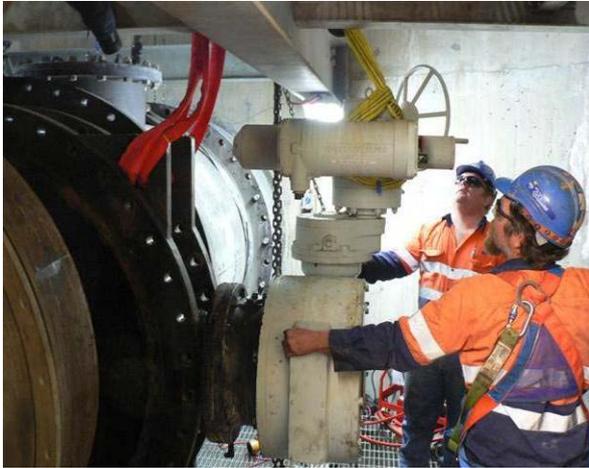
Figure 4: Restricted space during tower valve installation

- The tower valves are installed with the actuator mounted on the opposite side of the valve to which it had to be removed. The platform spacing is so confined that parts of the actuator and hand wheel protrude between the next platforms beams. To remove and install the valves the actuators had to be removed from the reduction gearboxes. During one

shutdown the actuator hand wheel assembly had been misaligned by 15 degrees during servicing. This was not noticed until the valve was being installed. The misalignment resulted in the actuator and hand wheel interfering with the platform beams above. This unforeseen problem resulted in the shutdown extending to nearly 10 hours.
