THERMAL INDUCED CRACKING PERFORMANCE OF RCC DAMS

Kenneth D HANSEN

Brian A FORBES

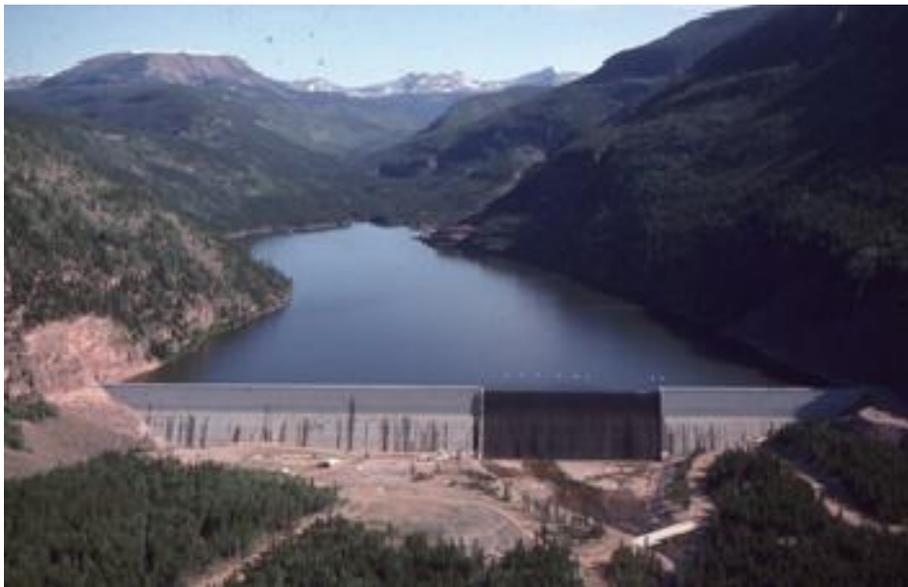
After the dam was completed in August 1987, 13 cracks developed in the dam at an average spacing of 49 m (see Fig. 1).

Ultimately, the number of cracks increased to 23 with a reduction in the average spacing to 35 m. In addition to the thermal related contraction, a number of the cracks may have been initiated by a horizontal downstream movement in the foundation rock of 10 mm after the reservoir water load was applied to the dam.

Fig. 1
Aerial view of Upper Stillwater Dam, Utah showing cracking

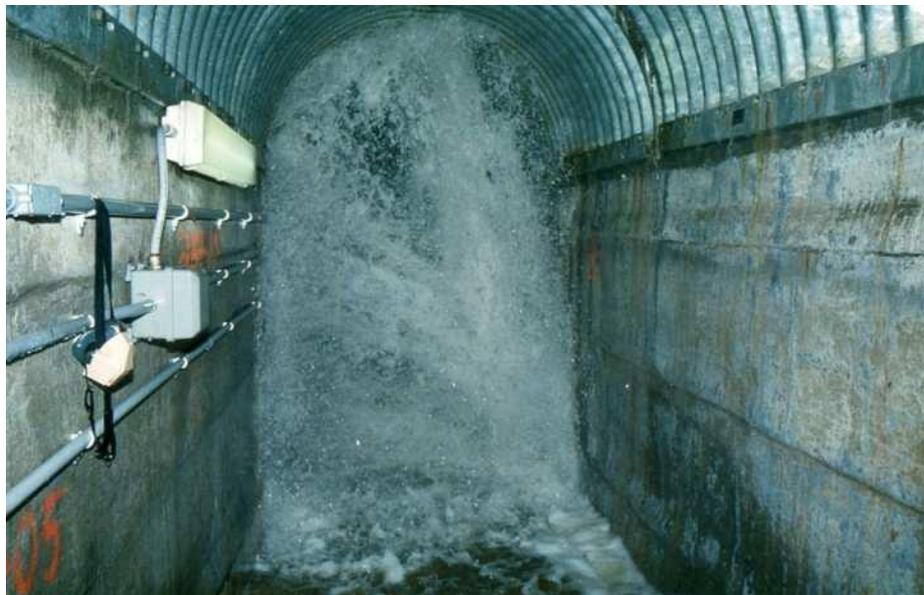
Crack repairs have been made on several occasions with varying results and costs. The US Bureau of Reclamation first decided to repair the widest crack (6.6 mm) at Sta. 25+20 (see Fig. 2) and three narrower cracks in 1990 using a stable hydrophilic polyurethane resin at a cost of about US\$600,000. This method only proved partially effective and not a long term solution.

Fig. 2
Leakage in gallery through major crack at Upper Stillwater Dam

Installation of a positive internal membrane was the fix selected for the three widest cracks, including the one at Sta. 25+20 which was now nearly 30 mm wide due to erosion from water passing through the crack. Here a corrugated stainless steel membrane 4.3 m wide was installed to completely cover this as well as two other major cracks. Vertical 150 mm nominal diameter holes were drilled into the RCC similar to a secant wall to produce a 114 mm wide slot for insertion of the

membrane in 6.1 m lengths. The steel membrane sections were welded together to produce three effective cutoff membranes varying in depth from 48 to 57 m. Hot bitumen was poured into the slot to encase the membrane and its enlarged ends fixed by cement grout to accommodate expansion and contraction of the membrane.

This contract also consisted of chemically grouting seven cracks with drains installed behind the remediation grouting. Seven more cracks had only drains installed downstream of them to relieve water pressures in the dam.

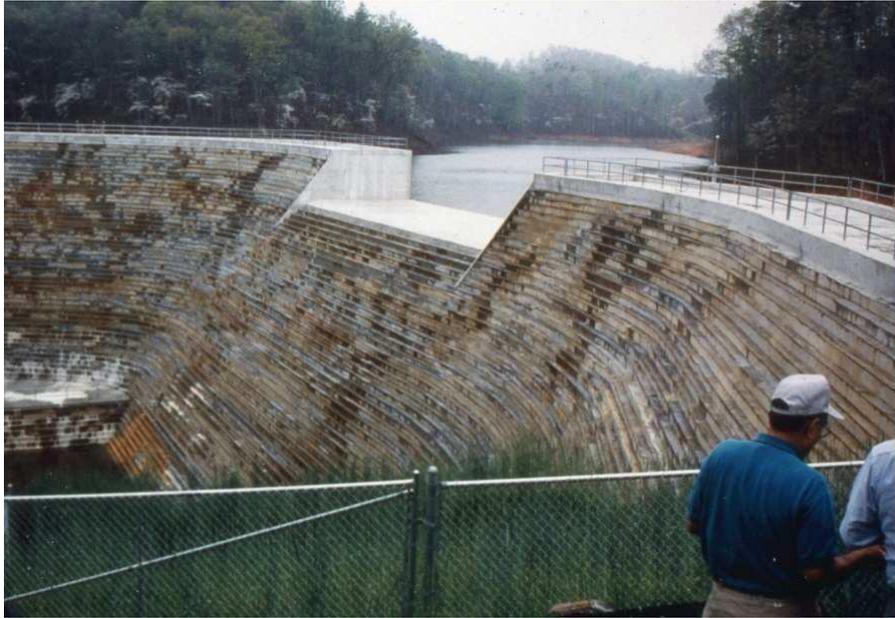
The owners then decided to proceed with higher placing temperatures, up to 26.7°C and accept the consequences rather than suspending RCC placement until the cooler time of the year. Except for one major crack, cracking observed on the downstream face was minor. The single wide crack is located about 0.6m inside the right end of the spillway and intersects the right gallery adit (see Fig. 3). Cracking at this location was not surprising as it is where there is a reduction in cross section due to the adit opening as well as close to a potential stress concentration where the dam's alignment turns abruptly downstream.

It was concluded by the design engineers that there was no conclusive evidence that any additional cracking occurred solely due to the increased RCC placing temperature. The thermal situation was aided somewhat when the measured peak interior temperature had been reduced by a greater heat loss to the atmosphere than the 25% loss assumed in the calculations.

Fig. 3
Crack at Hudson River No. 11 Dam, Georgia

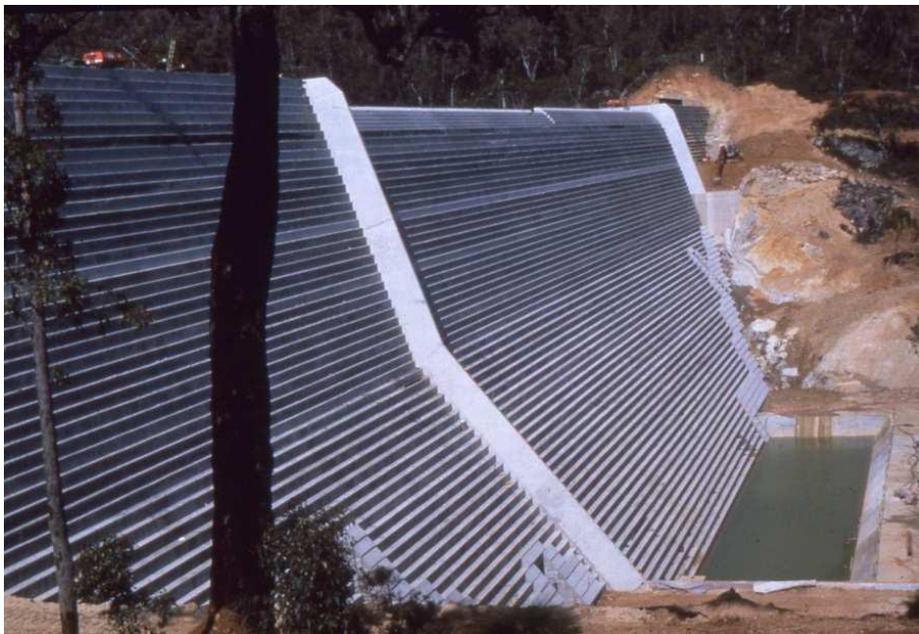
Fig. 4
New Victoria Dam, Western Australia

The dam (see Fig. 4) included five transverse joints with a spacing of up to 75 m. Two uncontrolled cracks initially developed between the relatively long joint spacing. One was in line with the gallery entrance (adit) and another between the end of the gallery and the right abutment. Both cracks were subsequently grouted.

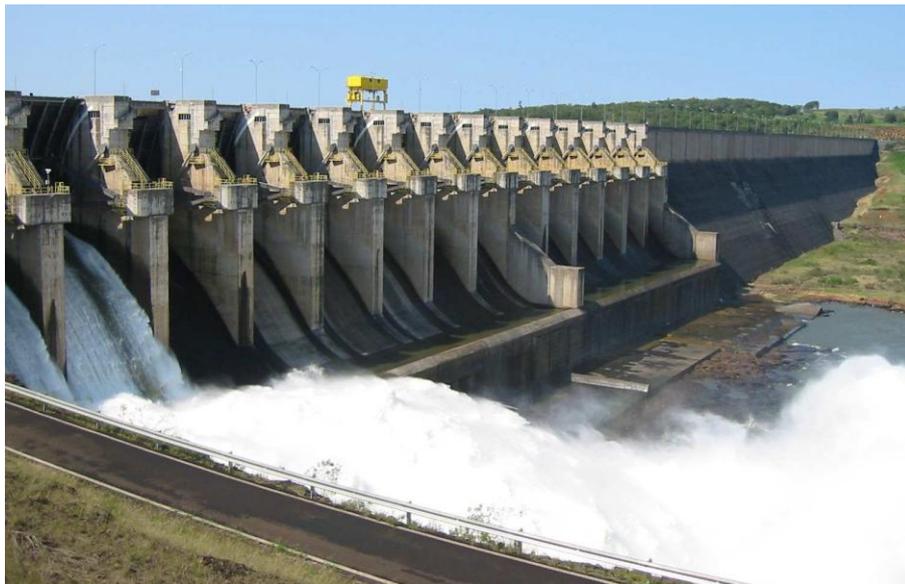
9-Salto Caxias Dam. The thermal cracking performance of Brazil's largest volume RCC dam is of interest because of the construction schedule. In addition operation of the dam during construction played a major role in the development of three major cracks (see Fig. 5).

Fig. 5
Salto Caxias Dam, Southern Brazil

The location of three major cracks is of interest. All three cracks are in the central river bed section where the RCC was placed last. One crack is near the left end of the section where the foundation rises creating a slightly smaller cross section. Another crack is in the first block adjacent to the previously placed spillway section where a stress concentration is likely. The third crack is located about halfway between the other two cracks and coincident with a partial transverse joint to relieve an excess cross canyon tensile stress.

These cracks were repaired soon after completion in 1999 with a variety of materials and mixture proportions. In general, the initial repairs were not successful in the long term and the owner undertook further repairs in 2006.

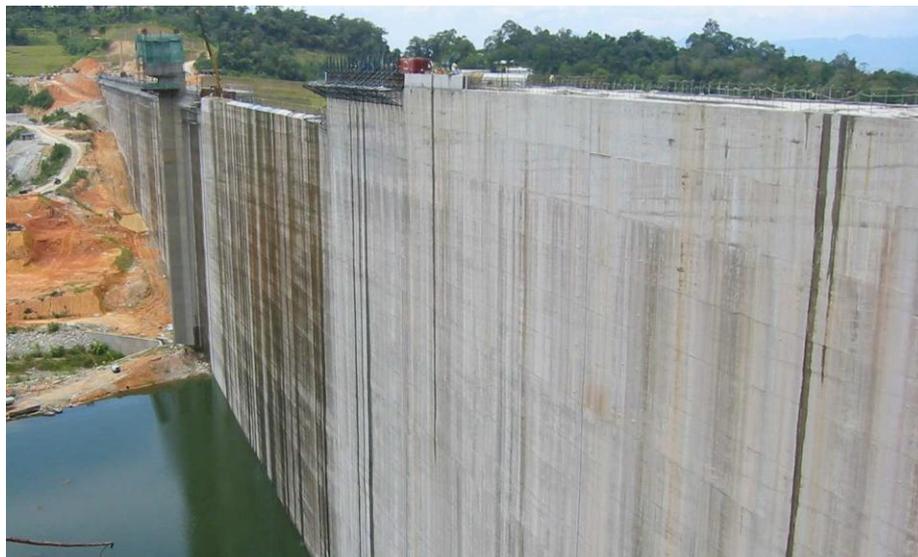
2-Kinta Dam, Malaysia (90 m high, 930,000 m³ RCC). Here transverse joints were designed to be placed at 30 m centres and the upstream 4 m of RCC cooled to 20°C, the remainder of the dam being placed un-cooled, reaching up to 30°C, all as determined by a detailed thermal stress analysis undertaken using ANSYS. The analysis showed the critical case was thermal shock cracking of the upstream face on first filling of the reservoir based on a 9 month RCC placing period. To prevent cracking the tensile strength of the upstream GERCC facing and adjacent RCC had to achieve 1.0 MPa at 90 days (see Fig 6). The contractor objected to any cooling of RCC, volunteering rather to reduce the spacing of the joints to 20 m, which still would not prevent cracking on first filling. His actual RCC placing time overran that expected during design from 9 to 22 months. When reservoir impoundment eventually took place, the tensile strength of the RCC facing was twice that required and consequently the predicted face cracking never occurred!

Fig 6
Kinta Dam, Ipoh Malaysia

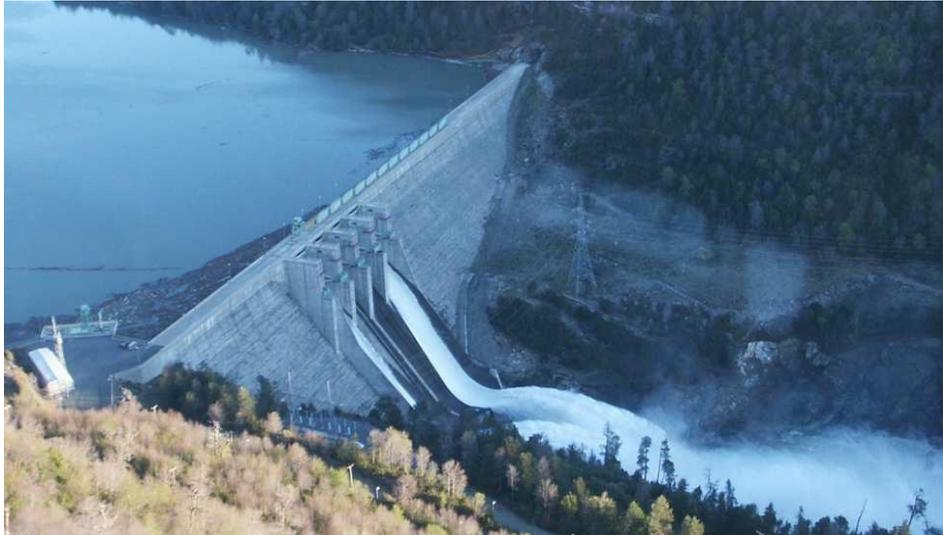
3-Pangue Dam, Chile (120 m high, 640,000 m³ RCC). A detailed thermal stress analysis determined the transverse joint spacing of 40 m, with the width of the last monolith block on each abutment being about 45 m (see Fig 7). Some months after impoundment, an inclined crack developed almost midway along the last block on the left abutment. The maximum height of the block was 30 m, reducing to zero. The crack was inclined in towards the abutment and normal to the axis of the dam. The last block on the opposite abutment had a max height of 70 m, reducing to 6 m but did not crack.

Fig 7
Pangue Dam, Southern Chile

Despite the results of a thermal stress analysis it would seem prudent to reduce by one-half, the joint spacing for the upper blocks where the height to block width ratio is significantly different to the remainder of the dam as analysed.
