# Design Considerations for Water Storage Structures on Porous Foundation in South West Western Australia

Michael Ashley, Robert Wark  
GHD

*Based on four case studies from south west Western Australia, this paper describes the extent of the problem, investigation and testing methods, design challenges and construction issues to be considered when constructing water storages on porous foundations.*

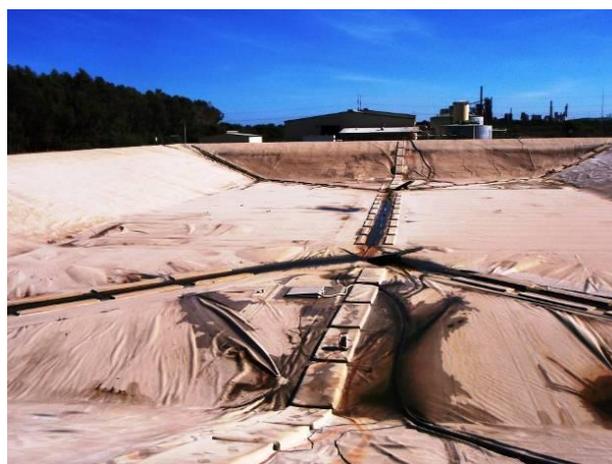
**Photograph 1 Northern Pond at KWRP prior to remedial works**

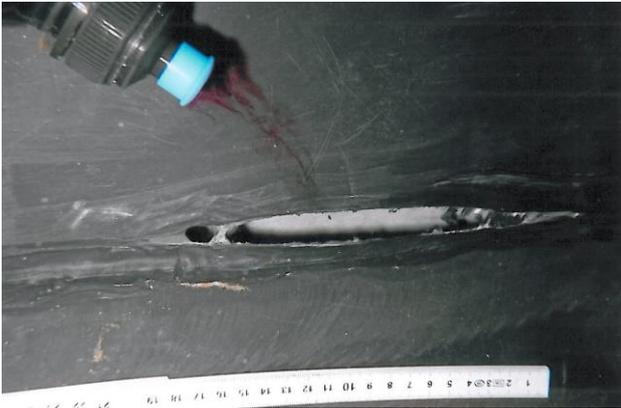
A diver inspection within the Northern Pond in 2010 revealed several cracks and tears in the single layer HDPE liner. A typical tear is shown in Photograph 2.

**Photograph 2 Tear near weld seam (dye check)**

The cause of the liner failure was not conclusively determined; however the following potential reasons were identified:

- Rapid loading of the liner stressed the weld/joints and may have caused tearing. Tearing may have occurred as the pond was emptied and refilled at a rate which exceeded operating guidelines.

- Anecdotal evidence suggested that the original design included a diffuser inlet located centrally in the pond. This system was changed to a simple inlet pipe located at the southeast corner of the pond. Movement of the inlet pipe may have resulted in the tearing of the liner joints and welds in the area.

- The embankments and foundations were constructed with the limestone marl material available on site. The materials were highly calcareous and may have adversely reacted with the slightly acidic treated water, resulting in partial dissolution of sections of the embankment and foundation and the creation of voids beneath the liner. The voids were likely to have caused the liner to stretch, causing new tears and widening of existing tears.

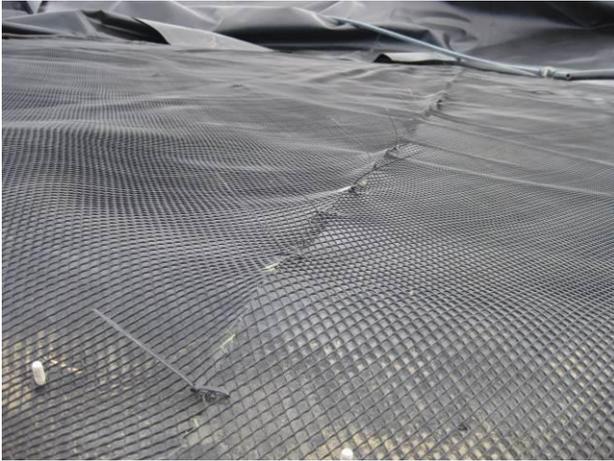
**Photograph 3 HDPE liner and permeable grid installation**

A clay liner was not considered further as it would be difficult to construct due to the steep embankments, and suitable clay material was not readily available. A double HDPE liner with intermediate permeable grid was preferred as the long-term solution as it provided two layers of leakage protection and reduced the risk of the chemically aggressive water dissolving the carbonate content of the foundation soils. If a leak occurred in the top liner layer, the design was that the leakage would be collected by the permeable grid layer. A similar liner system was successfully used for several ponds at the nearby Woodman Point Wastewater Treatment Plant. Photograph 3 shows the HDPE liner and permeable grid installation.

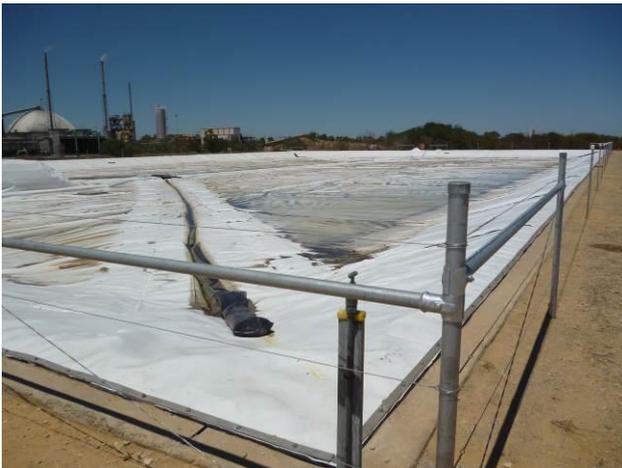
**Photograph 4 Northern Pond after remedial works**

The Northern and Southern Ponds have now been successfully remediated. Photograph 4 shows the Northern Pond after remedial works.

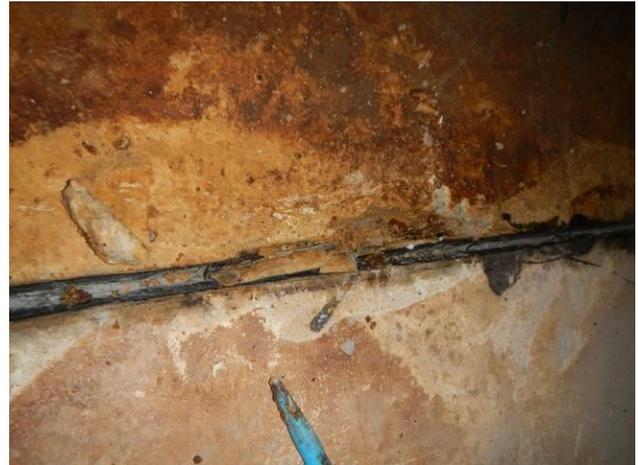
- Poor joint detailing leading to a failure of the joint sealant between slabs. A typical joint is shown in Photograph 5.
- Use of coastal limestone as bedding layer material. The bedding materials may have adversely reacted with the stored water, resulting in partial dissolution and voids beneath the liner.
- Structural failures of the slab foundations caused by insufficient compaction of the upper zone of sandy material below the reservoir, solution of lime or lime cementing.

**Photograph 5 Typical joint between concrete slabs**

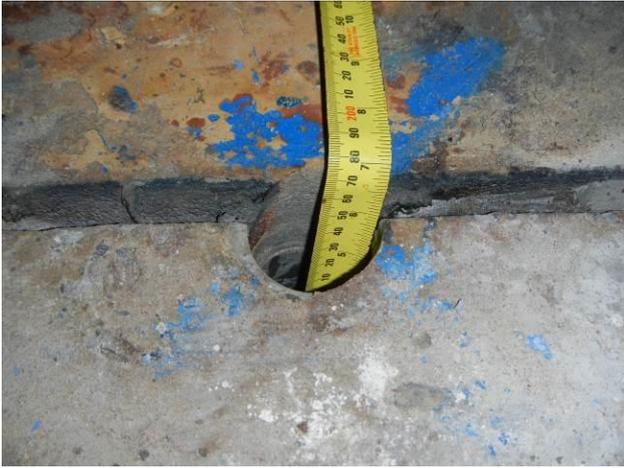
Micro seismic testing and coring investigations were undertaken which confirmed the deficiencies of the subgrade below the parts of the reservoir. The voids identified below the base slabs were subsequently grouted and the entire reservoir was lined with an unbonded HDPE liner. Photograph 6 shows a typical core drilled in the concrete at a joint.

**Photograph 6 Typical concrete core at joint**

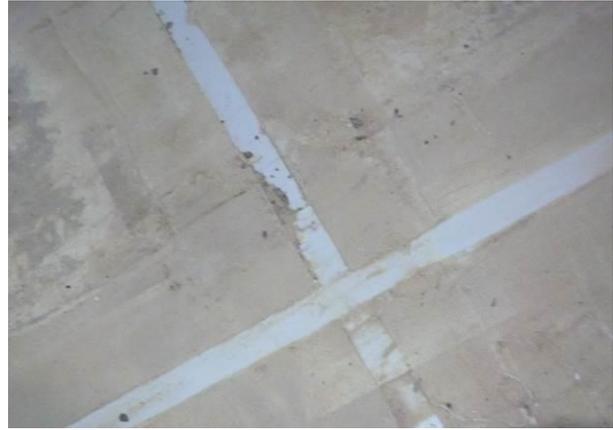
**Photograph 7 Typical joint seal repair**

- Removal existing HDPE liner progressively.
- Grout voids under slabs and core holes by jet grouting.
- Reinforce and reconstruct slab contraction joints with reinforced concrete.
- Apply an external polyolefin seal to seal the reconstructed joints.
- Repair and seal the edges of the remaining liner.
- Undertake ongoing monitoring and assessment of piezometers and water balance data.

The trial repair has been successful in that all the sealed joints are 100% water tight when tested by divers. However leakage through the remaining HDPE liner and concrete joints and further stages of the remedial works are to be undertaken to fully remedial the failed portions of the concrete liner.

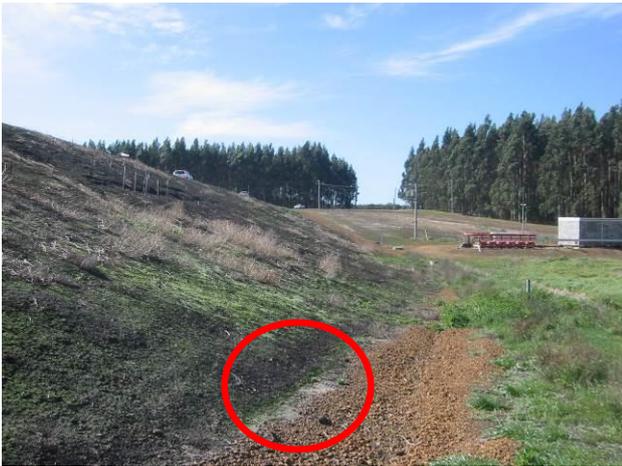
The downstream toe area at the first dam was observed as very wet throughout the year, which is an indication of significant seepage through the foundation. Photograph 8 shows seepage observed at the toe of the dam.

**Photograph 8 Seepage at downstream toe**

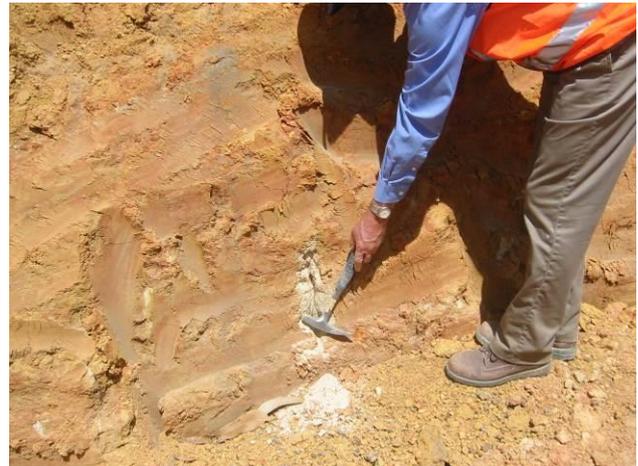
Photograph 9 shows a sand filled root hole located in the dam foundation during the geotechnical investigation.

**Photograph 9 Sand filled root hole in foundation**

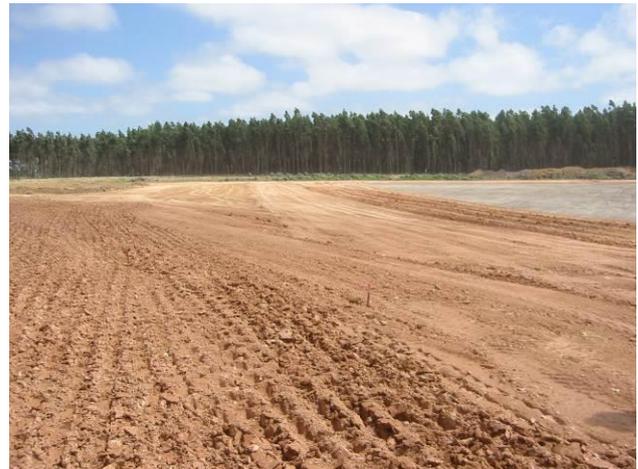
**Photograph 10 Reservoir basin lining works**

As a result of the findings of the investigations and the leakage at the first storage, the storage basin of the second dam was fully lined with a clay liner. The clay liner included a maximum hydraulic conductivity of  $1 \times 10^{-9} \text{ m/s}$  in accordance with the permeability guidelines contained in the Water & Rivers Commission Water Quality Protection Note "Low Hazard Wastewater Containment with Non-Synthetic (Clay) Liners". Photograph 10 shows the reservoir basin lining works.

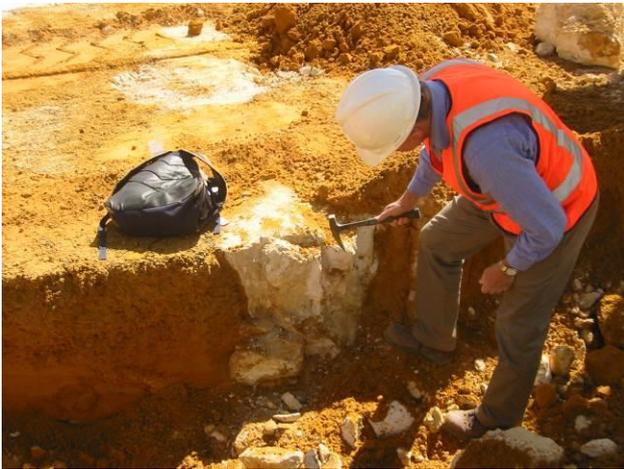
The geotechnical investigations indicated the geology at the dam site consisted of a layer of topsoil underlain by sand. Limestone was encountered at depths of 0.8 m and 5.3 m below surface level in a number of test pits at the dam site. Photograph 11 shows a typical limestone pinnacle encountered in the dam foundation.

**Photograph 11 Limestone pinnacle in foundation**

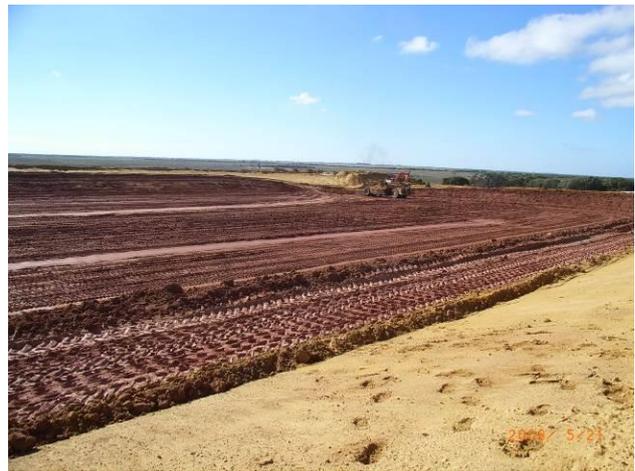
**Photograph 12 Clay liner construction**

The design included a 300 mm thick clay liner on the base and side slopes with a maximum hydraulic conductivity of  $1 \times 10^{-9}$  m/s. The thickness of liner was selected based on the permeability guidelines contained in the Water & Rivers Commission Water Quality Protection Note "Low Hazard Wastewater Containment with Non-Synthetic (Clay) Liners". The upstream faces were set at 1V:3H to enable the clay liner to be placed on the embankment earthfill with reasonable efficiency. The minimum drawdown level was set at 0.5 m above the reservoir floor level to reduce the risk of the clay liner drying out and cracking.

The technical specification required the Contractor to construct the embankment by lifting in horizontal layers. Constructing the liner up the slope was not permitted.
