An unusual tunnel collapse, the Hull Wastewater Transfer Tunnel

Australian Tunnelling Society

Wednesday, 26th March, 2014

Steve Macklin | Principal Tunnel Engineer/
Engineering Geologist, GHD Melbourne

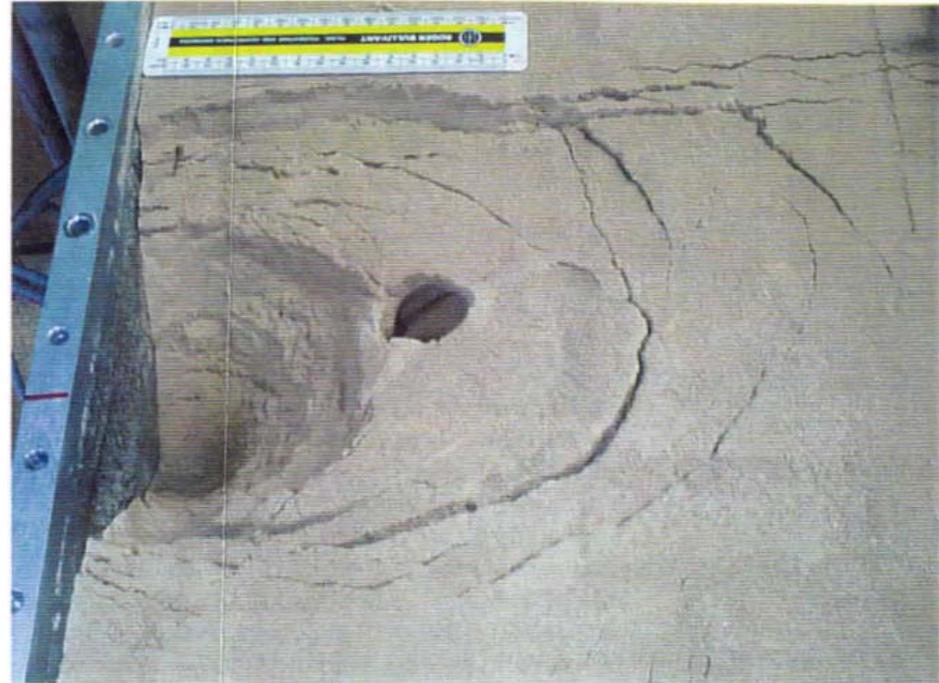
Centrifuge tests limited by modelling simplifications required, however confirmed:

- Tunnel buoyancy caused longitudinal deformation relative to fixity at the shaft
- softening/ disturbance of soil local to the shaft
- Circle joint opening
- If laminated clay in invert stays intact – NO FAILURE
- But if fine single size SAND gains access – FAILURE

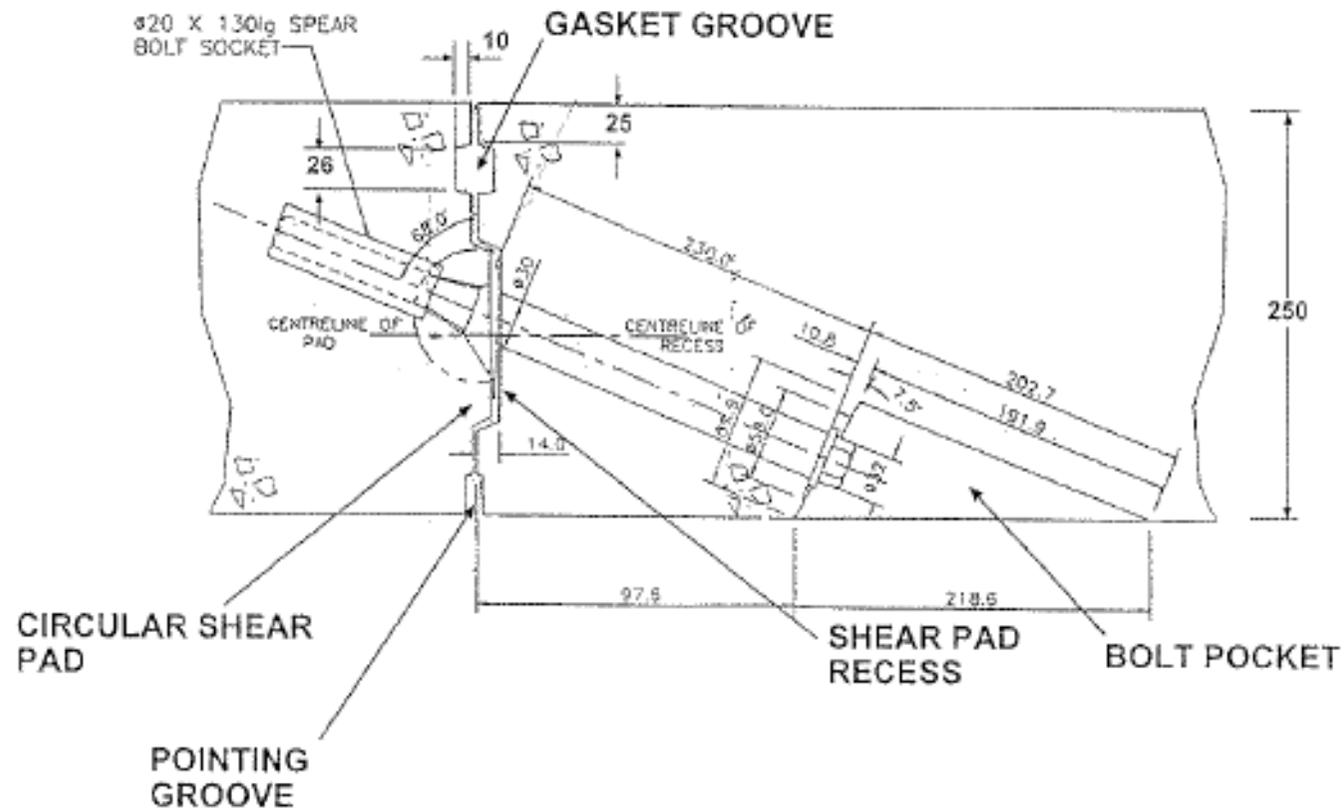
Consequence of longitudinal movement: “top hat incident”? shear pads failure? Nib crushed – gasket bypassed?
