**North American Society for Trenchless Technology (NASTT)
NASTT's 2015 No-Dig Show**

Paper MM-T1-05

Questions Answered By NDT Inspection for Forcemains in Service

Dwayne Hofstetter, Conestoga-Rovers & Associates, Waterloo, Ontario
Brad Marin, Conestoga-Rovers & Associates, Waterloo, Ontario

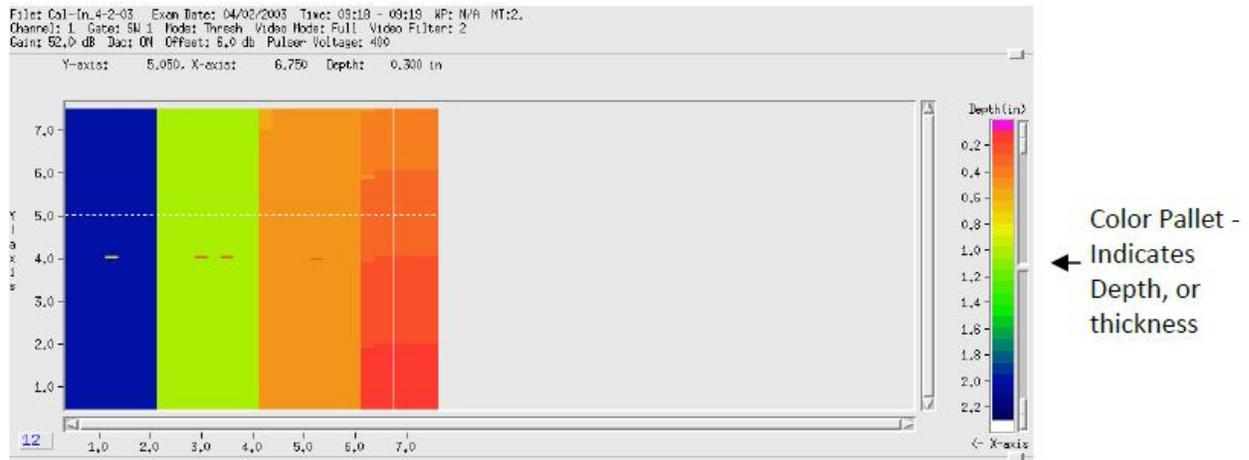
Figure 5. Example of AUT Scanning—Image Scan

The test results then are recorded in a color pallet indicating the depth/thickness of the pipe, starting at the 12 o'clock position, or in our case, 0 degrees.

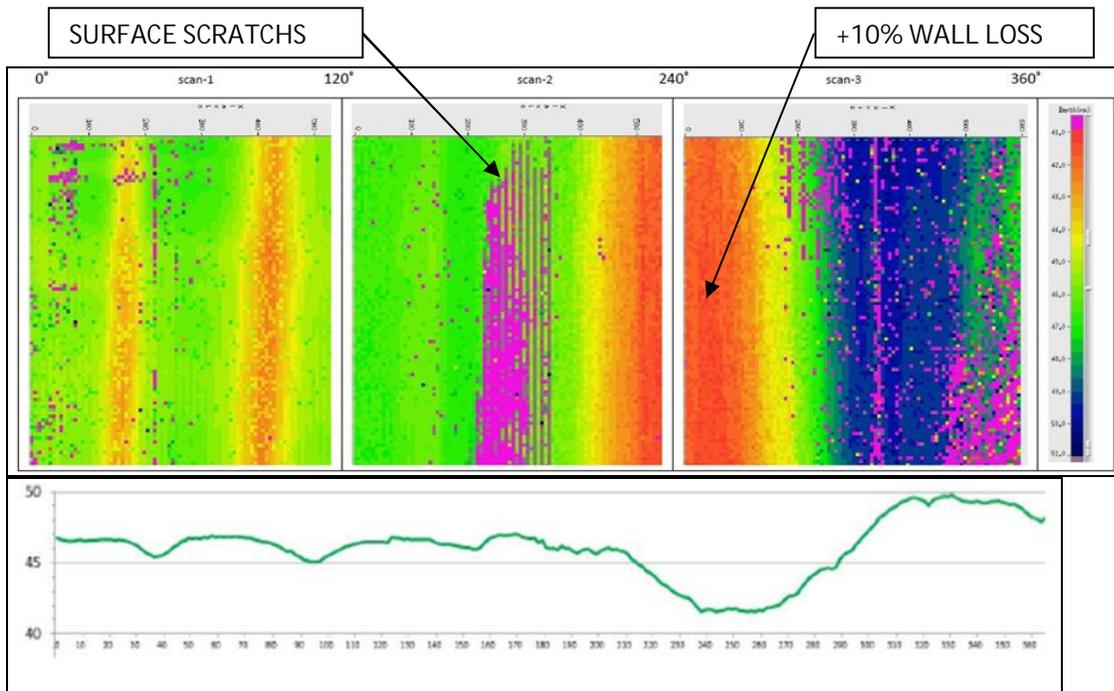
Figure 6. Scan Test Results

The AUT scanning results showed a reduction in wall thickness for both the HDPE concentrate and tailings pipelines. The reduction in wall thickness was beyond the ASTM F-714 standard set for maximum design pressure rating. The ASTM standard allows for local physical inclusion in the surface of up to 10 percent of the manufactured wall thickness. Any inclusion or loss in wall thickness greater than 10 percent should necessitate the replacement of the pipe prior to continued operations at the maximum design pressure rating. The AUT scans for the HDPE concentrate and tailings pipes show the following results:

- The 350mm (14 inch) HDPE concentrate pipe showed a wall thickness reduction in excess of 10 to 20 percent, showing a maximum reduction of approximately 5 mm.
- The 500 mm (30 inch) HDPE tailings pipe showed a wall thickness reduction for 10 to 15 percent, showing a maximum reduction of approximately 7 mm.

This reduction in wall thickness was related to erosion losses in the interior of the pipe, and as such, it was considered to be continuous along the length of the pipe.

Based on the findings of the AUT scanning and visual inspections and the duration of future usage, CRA recommended that the pipelines be temporarily bypassed and replaced prior to earth grading and excavation. The general advantages for bypassing the pipe include the following:

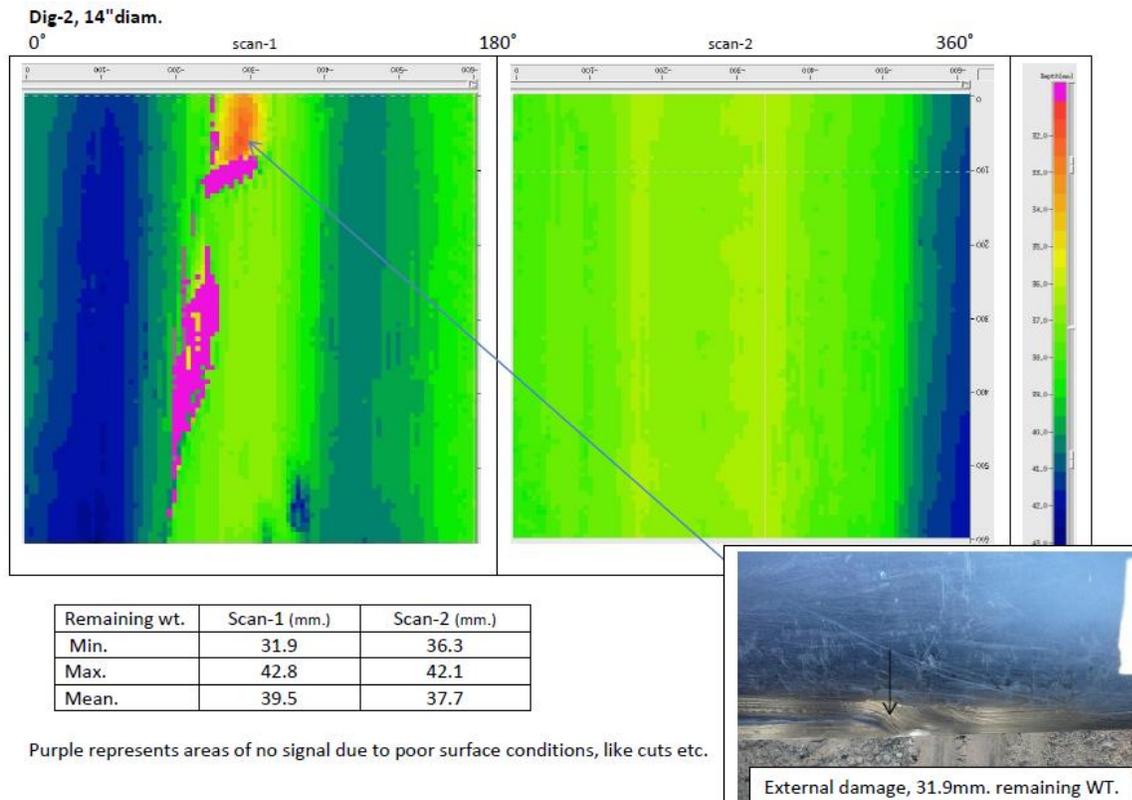
Figure 7. Test Results with Surface Deformation

- The 350mm(14 inch) HDPE concentrate pipe showed external scaring ranging in thickness from 1 to 8 percent of the total wall thickness.
- The 500mm (30 inch) HDPE tailings pipe showed external scaring ranging in thickness from 1 to 5 percent, and an existing repair coupling on the pipe was found in the test pit area.

The damage observed on the surface of the pipe was likely related to handling during installation. It may also have been due to handling during the completion of repairs. The presence of scaring and damage to the outer surface of the pipeline further decreases the effective pipe wall thickness and needed to be considered in combination with erosion or internal wall loss.
