# Quipolly Dam safety upgrade

**Peter A. Ballantine**

*Dams Service Group Manager, GHD, NSW*

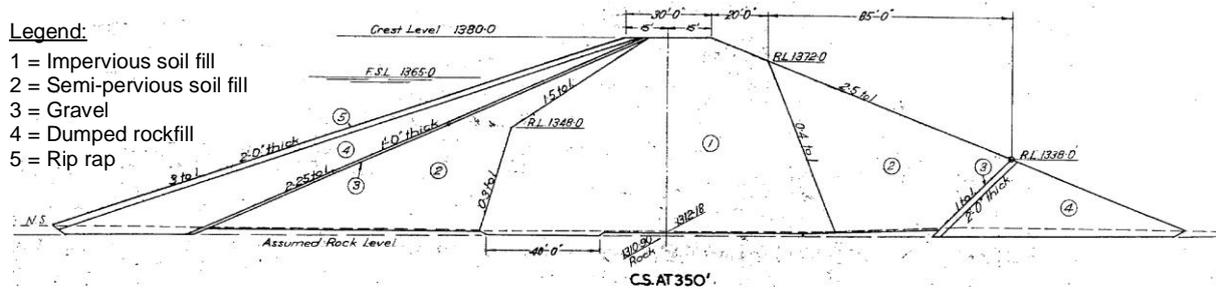
**Figure 1. Original embankment profile**

The risk assessment (URS 2006) identified the following principle deficiencies for Quipolly Dam (Figure 1):

- Potential piping through the upper section of the dam embankment due to drying out and associated micro-cracking (found in the upper 1.5 to 2.0 m) of the earthfill (the cracking was found in the core, but due to the similar nature of the materials, it was assumed that cracking could occur across the full dam crest width);
- Potential piping through the embankment alongside the vertical concrete spillway chute retaining wall;
- Inadequate spillway capacity (the dam crest flood had an estimated 1:800 Annual Exceedance Probability, or AEP).

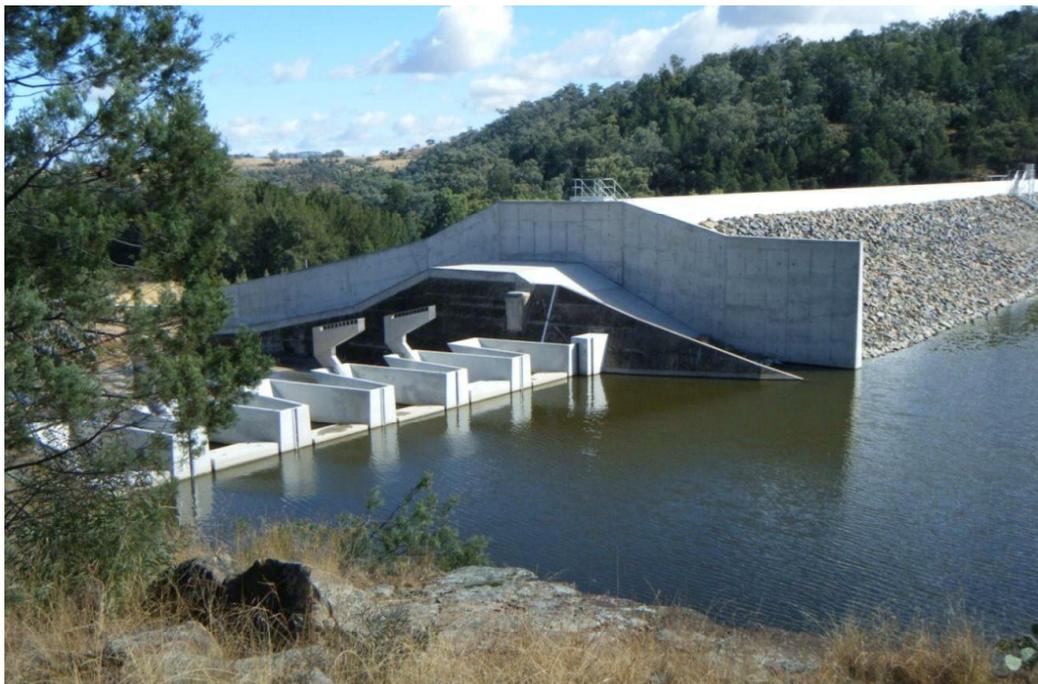
**Figure 2. View of upstream side of embankment and Fusegate units in spillway (note extended upstream retaining wall on Auxiliary Spillway)**

In line with requirements of LPSC (to increase available storage to facilitate future development), the storage level was increased by an effective 2.0 m (40% capacity increase) by the installation of 2.6 m high Hydroplus Fusegate units (see Figure 2). The Fusegates were designed to tip at flood AEPs between 800 and 1,000, which LPSC considered to present a reasonable economic risk. The main advantage of the Fusegates is the increased spillway area available after washout, which in turn reduces the total height to which the embankment needs to be raised. New reinforced concrete Fusegate foundations were placed slightly upstream of the original spillway channel crest wall. Steel anchor bars were embedded into the foundation rock to resist horizontal forces imposed by the Fusegates on their foundations. New side walls were provided against which the Fusegate units sealed.

A model study conducted by Hydroplus to test operation of the Fusegate units found that significant flow occurred parallel to the embankment, which resulted in unsteady flow conditions through the spillway. In order to improve flow conditions, the auxiliary spillway retaining wall was extended on the upstream side. This detail can be seen in Figure 2.

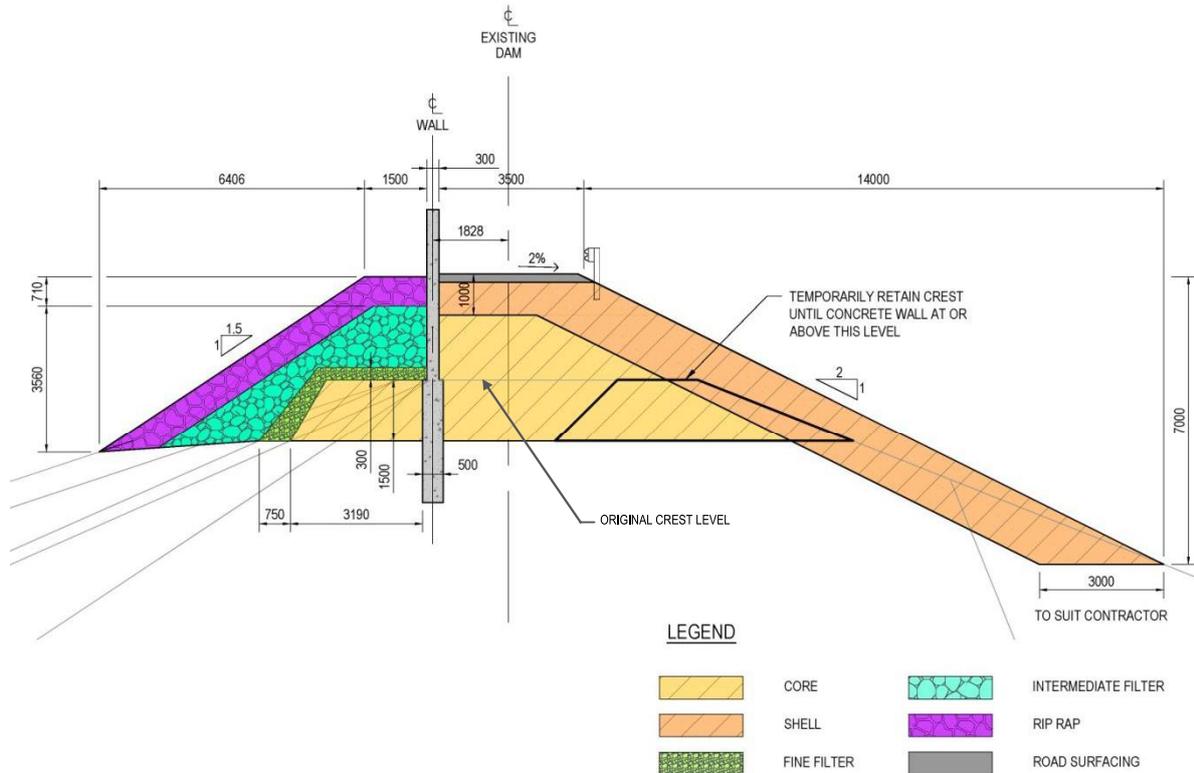
**Figure 3. Embankment crest profile**

The embankment crest was raised by a combination of earthfill and reinforced concrete crest wall. The original crest was approximately 9 m wide. By locally steepening the crest profile, both upstream and downstream, and reducing the crest width to 3.0 m, the earthfill embankment crest was raised by 2.5 m. The embedded crest wall provided an additional 1.65 m, bringing the total height by which the crest was raised to 4.15 m. This was sufficient to pass the 1:100,000 AEP design flood with a freeboard of 0.4 m after washout of the

Fusegate units. Earthfill obtained from local borrowpits was placed on the downstream side of the crest wall, while earthfill supported by filters and rip rap was placed on the upstream side. Details of the crest layout are shown in Figure .

The upper 1.5 m section of the embankment was reconstructed in order to remediate the micro-cracking which was present. After excavation of the upper 1.5 m and before reconstruction thereof, the reinforced concrete crest wall was embedded 1.5 m into the embankment. This effectively provided an impermeable barrier within the upper sections of the embankment where micro-cracking was present and reduced the risk of piping. The details of the crest wall are shown in Figure above (see the Construction Stage section in regard to mitigation of the risk of overtopping during construction).

To provide sufficient area for construction of the steepened downstream embankment profile, the Contractor was permitted to excavate a working platform within the embankment, at the point at which the embankment was steepened (refer to note “to suit Contractor” in Figure 3).

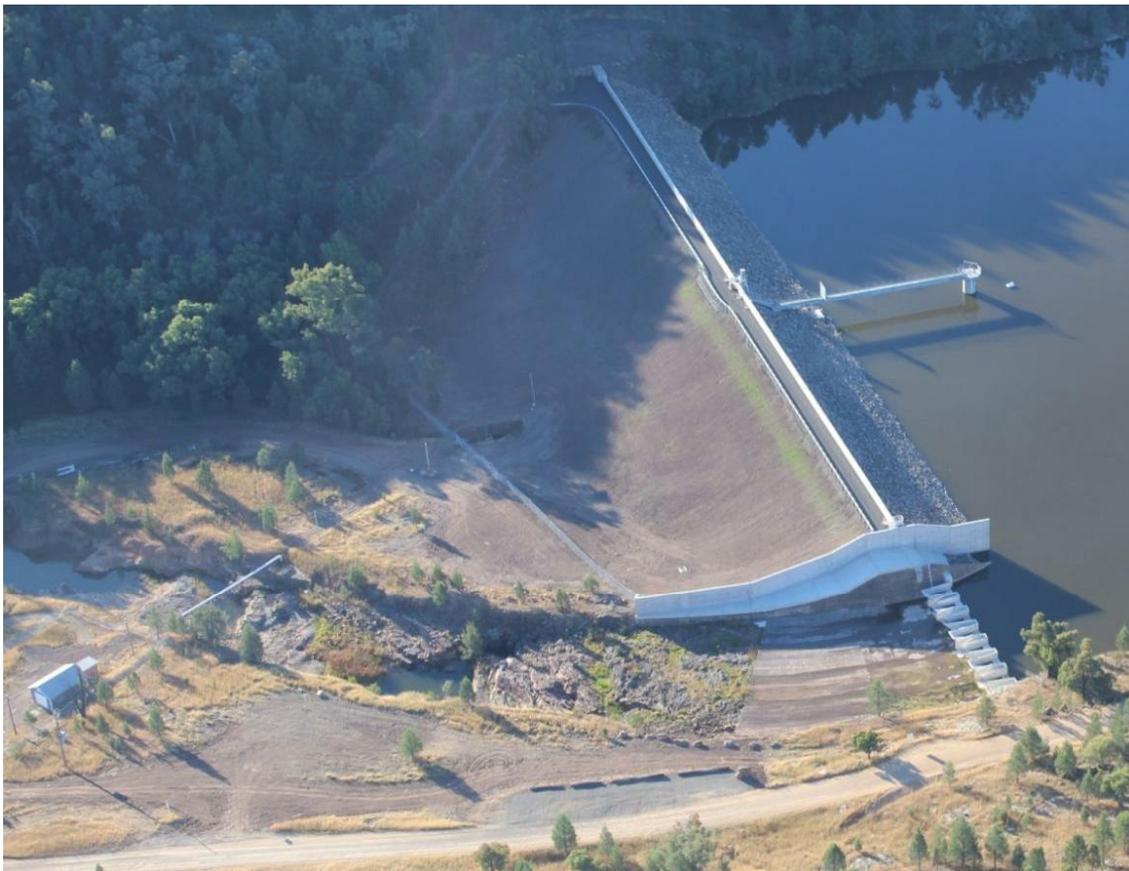
**Figure 6. Aerial view of completed embankment and spillway**

The intake tower bridge piers were made of wood, which had become severely weathered. It was therefore decided to replace these wooden piers. Two bridge pier foundations were below full supply level and would have required divers to place new piers. It was therefore decided to support the existing bridge with new beams, which could span this distance and provide only one pier for the bridge (see Figure 6).

No major unforeseen conditions were encountered during construction. An aerial view of the embankment after completion of construction is shown in Figure 6. Figure 2 shows a view of the upstream side of the completed embankment.
