1. Introduction

This report is the final report for this project on completion of Milestone No. 6. It consolidates results from the urine-separating dry composting toilet trial at the Maryborough Education Centre.

4. Approval, Design, Construction and Commissioning of the Demonstration Installation

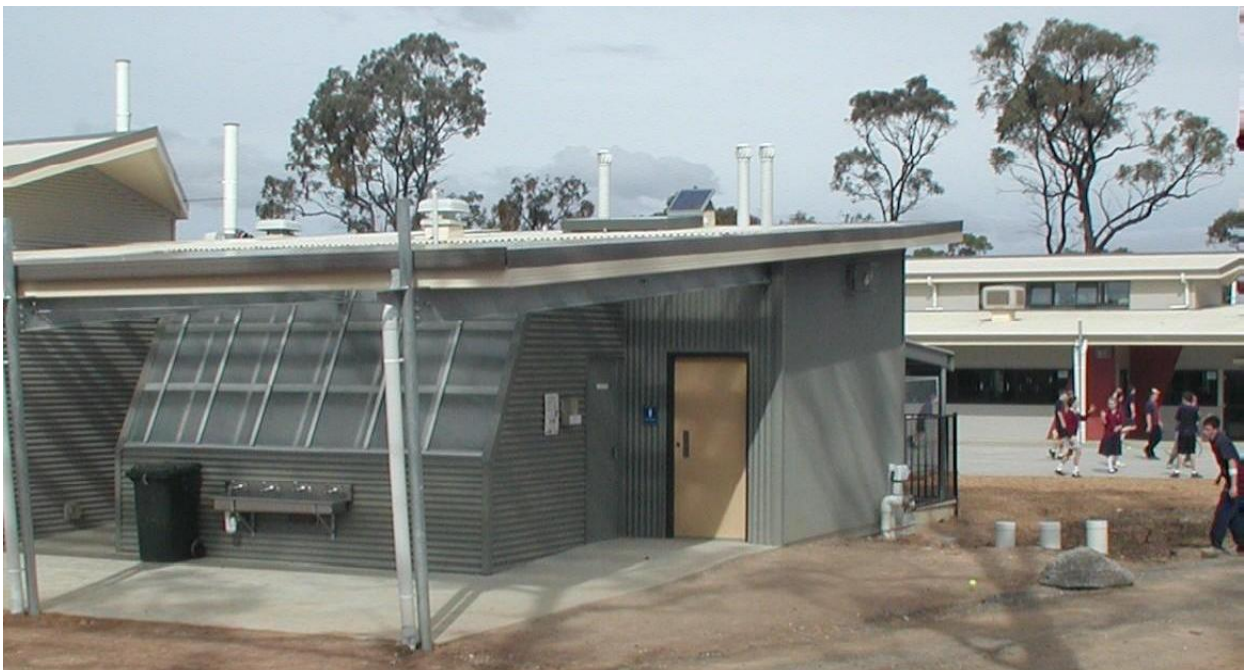
Figure 2 shows the urine-separating dry composting toilet block and its greenhouse-type west-facing structure. A solar-powered fan system and heat exchanger (a commercially produced unit known as a “Sun Lizard”) was installed to assist in supplying warm air to the composters and the solar photovoltaic panel for this is visible between the roof vents. The flat plate on the roof to the left of the solar panel is a black painted heat exchanger through which air is sucked by the solar powered fan. This air entering the solar heat exchanger is drawn from the top of the greenhouse space. Electric fans plus wind-driven fans in cowls on the three discharge vents in the roof maintain a flow of air down through the toilet pedestals and also draw air into the base of the composters from the Sun Lizard (for much of the trial, one of the composters, F2, drew its air supply from the greenhouse space via an electric heater in order to control composter internal temperature. The airflow down through the toilet pedestals prevents odour in the toilet room. Initially, timers controlled the electric fans so that energy use and the cooling effect of air is minimised overnight. Unreliability of the timers resulted in periods of insufficient ventilation during school hours so the fans were then turned on 24 hours per day. The waterless urinals include an oil-filled seal to prevent odour from urine. An in-ground biofilter removes odour from the urine and leachate tank vents. The three pipes stubs pointing up from the ground, on the right in Figure 2 are part of the biofilter and allow for future connection of the roof vents to the biofilter if necessary.

Figure 2 Outside view of structure from the West

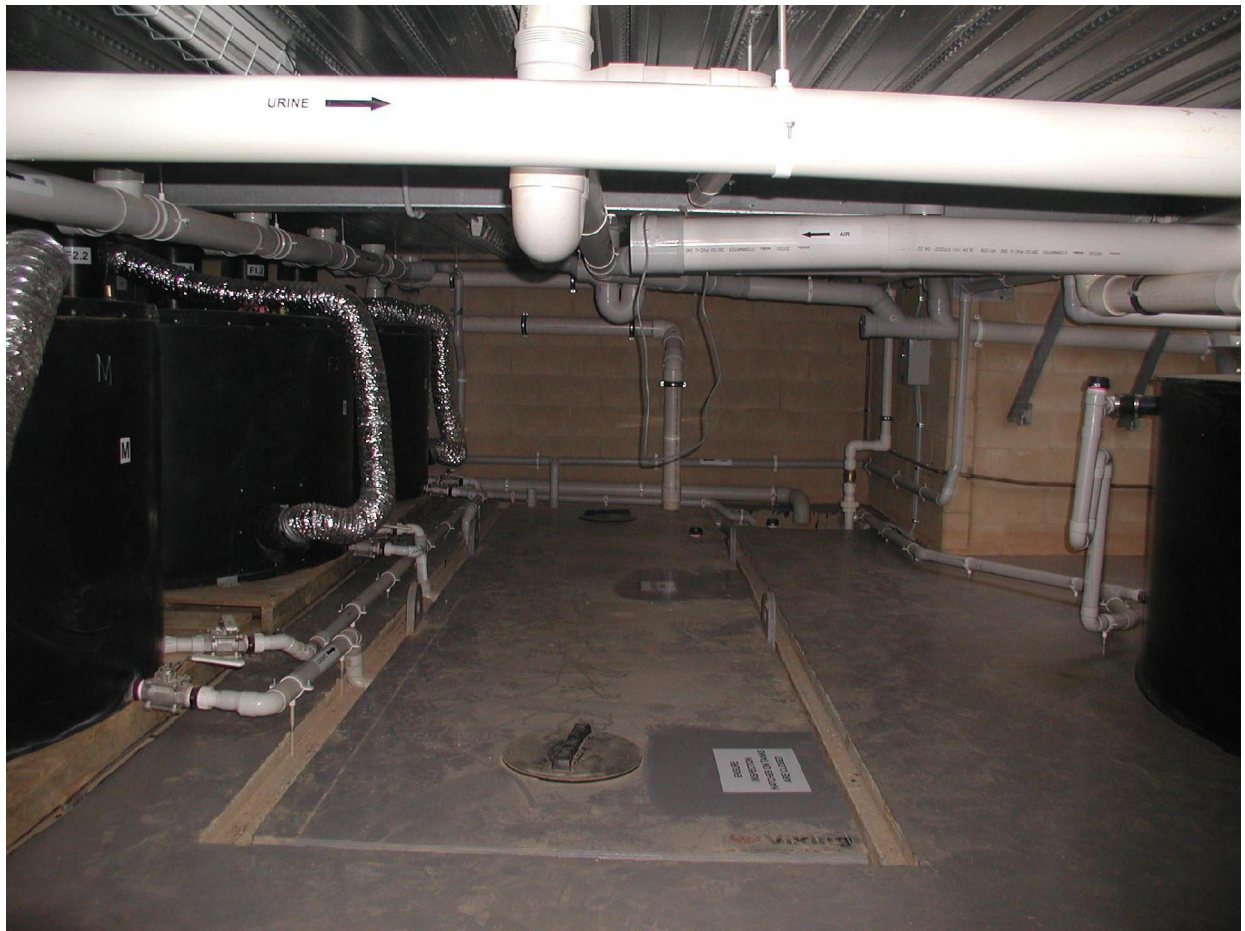
Three Rotaloo® Maxi 2000 composters in the basement (shown on the left in Figure 3) connect directly to two ceramic urine-separating pedestals. Each composter contains eight triangular 50 kg capacity HDPE compost bins on a carousel. Two bins are active at any one time. The 2.7 kL PVC leachate tank (centre), in which any unseparated urine (or added water) that has drained through the holes in the bottom of the composting bins is collected, is in the floor. The 4.3 kL HDPE urine tank, to which separated urine flows via PVC pipework, is located opposite the composters (on the right).

Figure 3 View inside basement
