4. Further Investigations

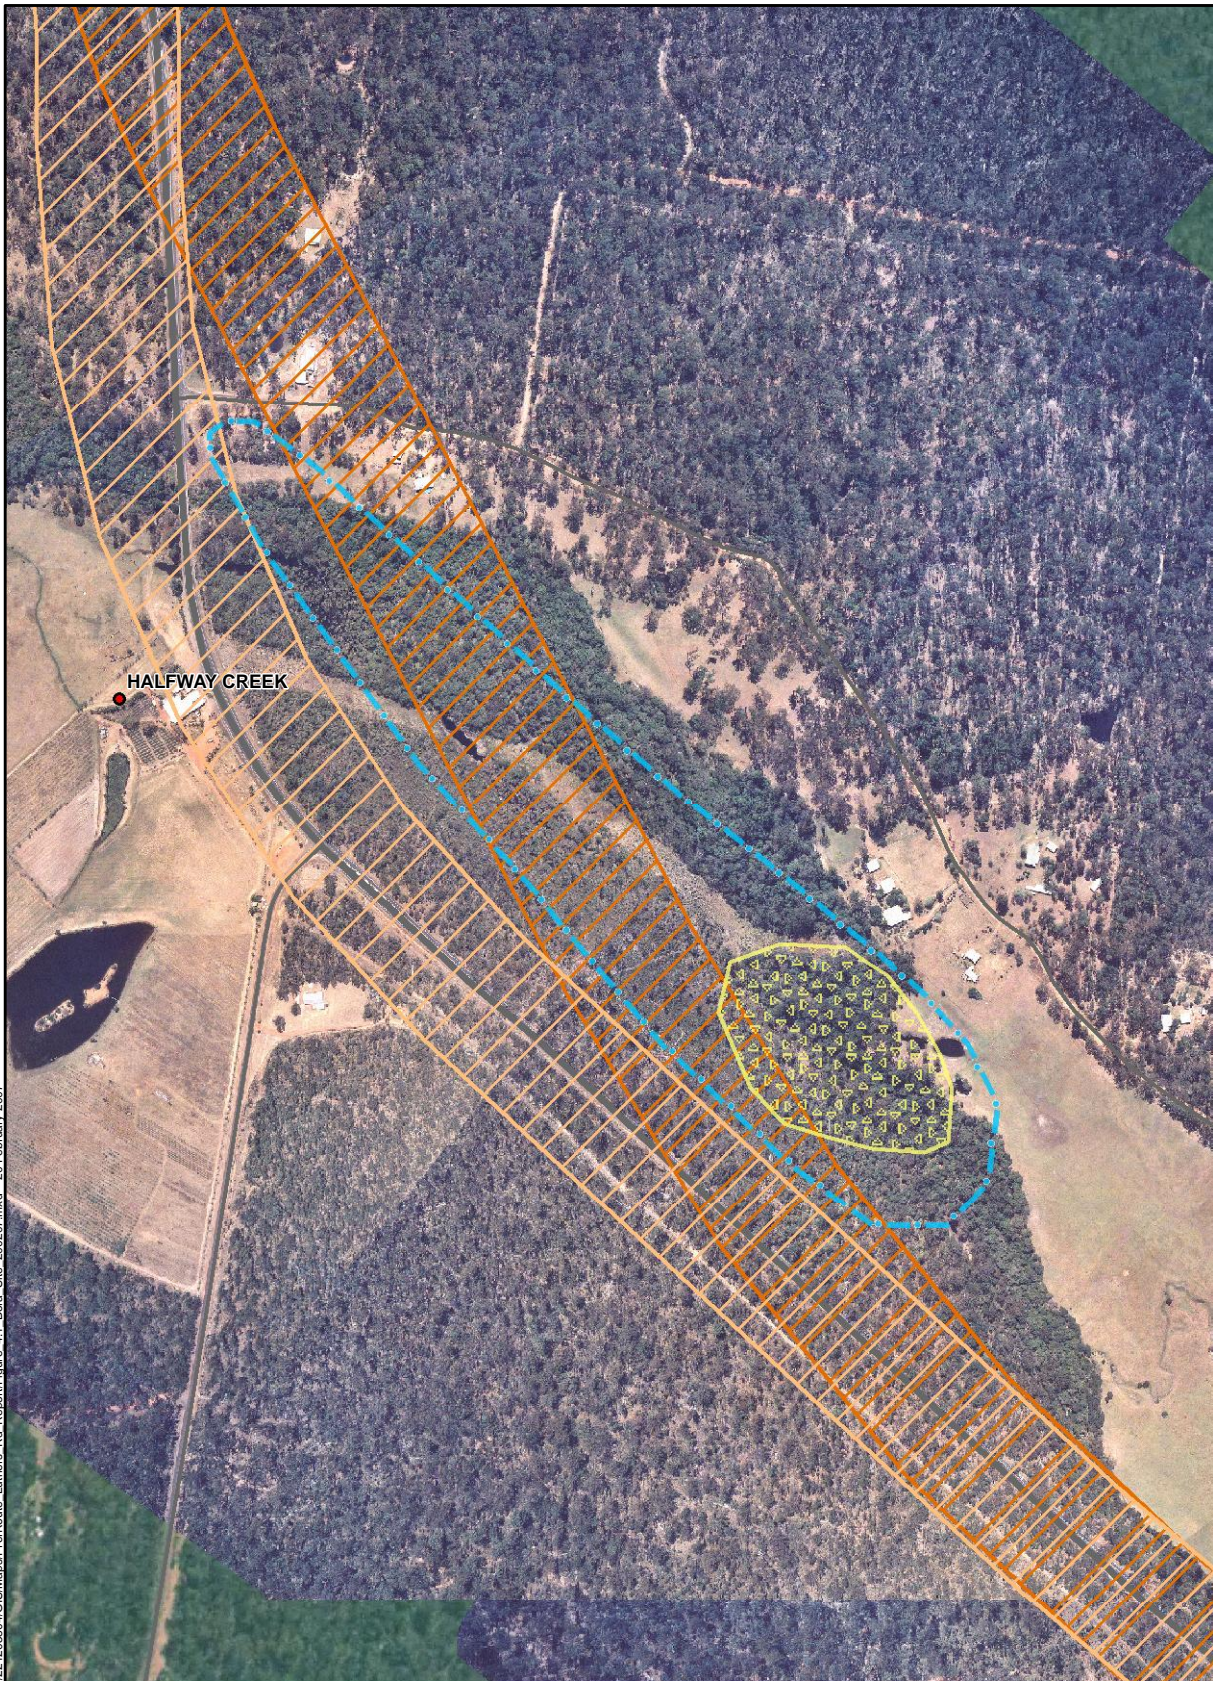
Figure 4.1

The refined location was subject to further site inspection in September 2006 with the Garby Elders and Grafton-Ngerrie Local Aboriginal Land Council. The inspection did not result in conclusive identification of the bora site however, the Elders narrowed the location down to an area of general cultural sensitivity (Figure 4.1), which was subsequently agreed by other Elders not in attendance at the site inspection.

Approximate location of Bora Site at Halfway Creek

The uncertainty relating to the location of the bora site resulted in the development of the combined Blue / Orange option because the refined Orange option may potentially impact on the bora site and surrounding culturally sensitive land.
