The Lessons Learned and Construction Challenges for the Leslie Harrison Dam Upgrade

Leslie Harrison Dam is located on Tingalpa Creek in the Redlands region, approximately 18 km southeast of Brisbane. It is classified as an extreme hazard category dam with a large population at risk only a short distance downstream.

The dam comprises a 25 m high zoned earthfill embankment, with a dry well concrete intake tower and an outlet conduit located at the base of the dam near the old river channel. The spillway has a 43 m wide concrete gravity ogee crest, with a concrete lined chute terminating in an energy dissipator structure.

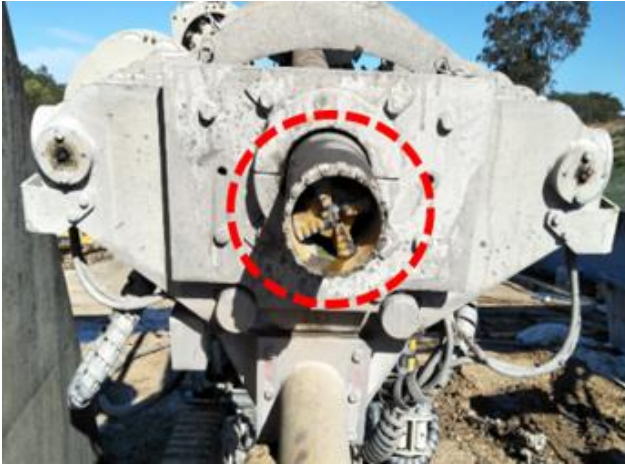
Figure 2 - Drill head showing casing (circled) and wash bore bit

Considerable time and effort was spent by the construction team assessing the drilling method for the anchors and drains in the spillway. While there was a good understanding of the geology beneath the spillway, which indicated variability in localised outcrops of weaker materials (i.e. coal seams), there was limited information from the original construction records regarding the methods that were used to treat them at the time. The key concern identified was damage to the spillway foundation from uncontrolled pressures during drilling for installation of anchors and drains (i.e. hydro fracture).

- Advancing a casing head ahead of the wash bore drill head (Figure 2);
- Keeping feed water pressures as low as possible during drilling;
- Monitoring any pressure changes in feed water during drilling;
- Monitoring existing spillway drains for any changes in flow during drilling;
- Downhole camera inspections following drilling.

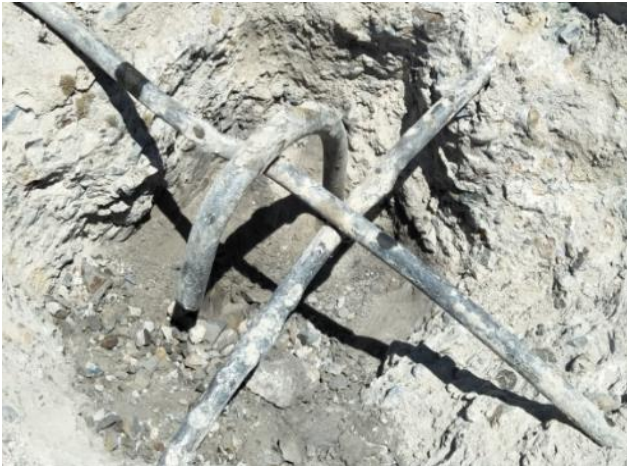
Figure 3 - Condition of existing reinforcement

By exposing the existing reinforcement at several locations (Figure 3), the following was established:

- Reinforcement within the existing concrete was in good condition with minimal signs of corrosion. This included reinforcement in areas that have been inundated by tidal flows for the past 50 years;
- Reinforcement at the interface of concrete and underlying foundation showed some evidence of corrosion. The maximum loss of section was measured at 20%, which agreed with design assumptions. Again, this included reinforcement in areas that have been inundated by tidal flows for the past 50 years.

The results of the investigation showed that existing reinforcement in half century old dams should not automatically be considered suspect or beyond its design life without first completing investigations. This information will be of relevance to future dam upgrades in Southeast Queensland (although the importance of investigations on a case-by-case basis is acknowledged with respect to making dam safety decisions).

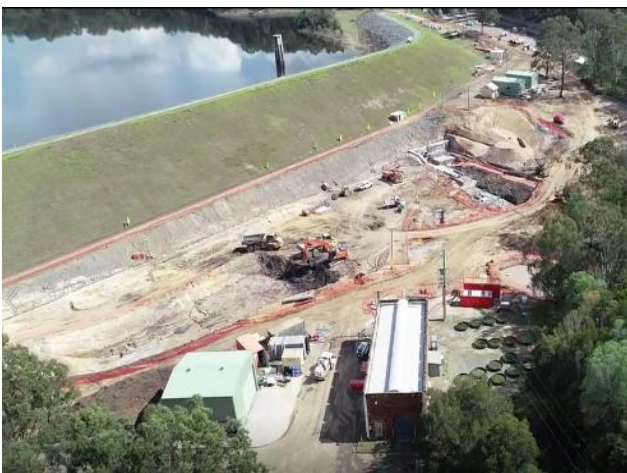
Figure 4 - Excavation at toe (looking upstream)

The design solution for the downstream shear key works involved the 5-10 m deep excavation of all existing liquefiable alluvial material down to a rock foundation. This was followed by replacement with zoned sand, gravel and rockfill quarry run materials.

As the dam is used for water supply purposes, the Full Supply Level (FSL) was maintained throughout the project, and construction of the downstream shear key therefore presented one of the highest risk activities for the project (Figure 4).

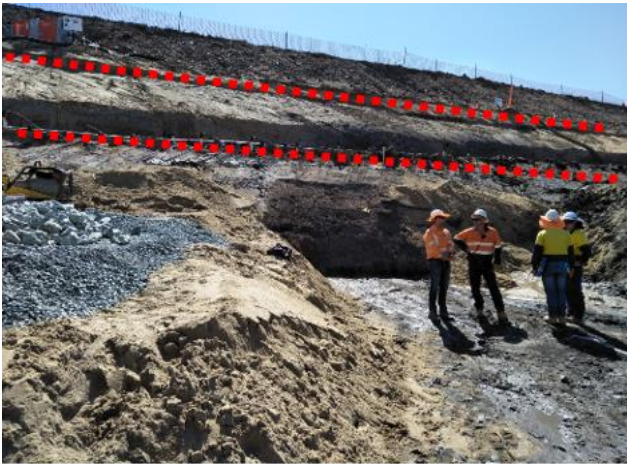
Figure 6 - Double row of dewatering wellpoints (indicated as shown)

Initially, a single line of wellpoints were designed and installed to remove groundwater from the excavation area around the perimeter. Although the wellpoints were functioning, groundwater levels were not able to be lowered below safe excavation levels. The decision was made by the Contractor to install a second line of wellpoints at a lower elevation to supplement the first installation (Figure 6). This proved successful and excavation was able to proceed safely without any incidents throughout construction works while the dam was maintained at FSL.

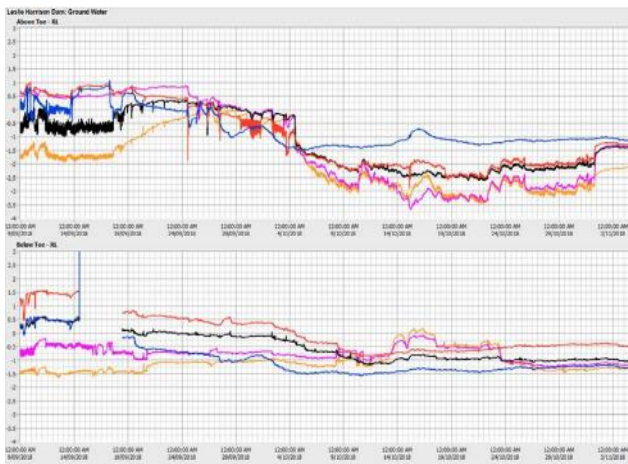
Figure 7 - Web based portal for piezometer data

Acceptable excavation and groundwater levels were specified according to slope stability analyses performed by the design team. The installation of telemetered piezometers and tilt meters allowed the construction team to monitor groundwater levels and movement in real time via a web-based portal (Figure 7). The advantages of installing telemetered piezometers and monitoring included:

- Dam safety was monitored and maintained at all stages of excavation. This was particularly relevant overnight when there was no visual monitoring on site;
- It allowed early warning for slope stability issues and time to rectify any concerns identified;
- The efficiency of the dewatering system could be readily observed. This facilitated a robust discussion on the installation of a second line of wellpoints.

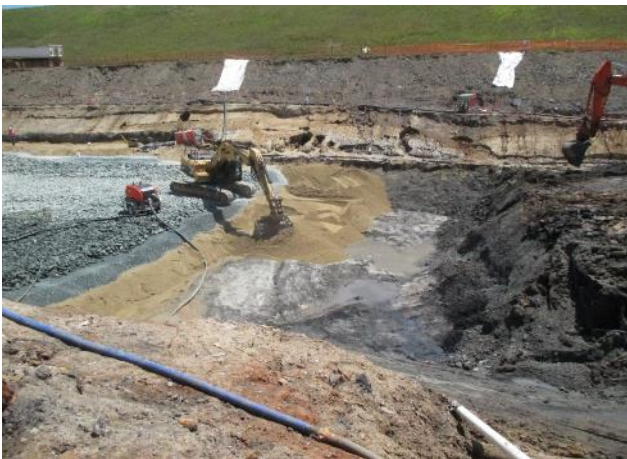
Figure 8 - Simultaneous excavation and backfill

Given the depth and extent of excavation required, backfill needed to be as fast and efficient as possible (Figure 8). Instead of specifying earthfill, the design team incorporated the placement of gravel and rockfill material. The lessons learned here were that placement of gravel and rockfill material had the following benefits when compared to earthfill material:

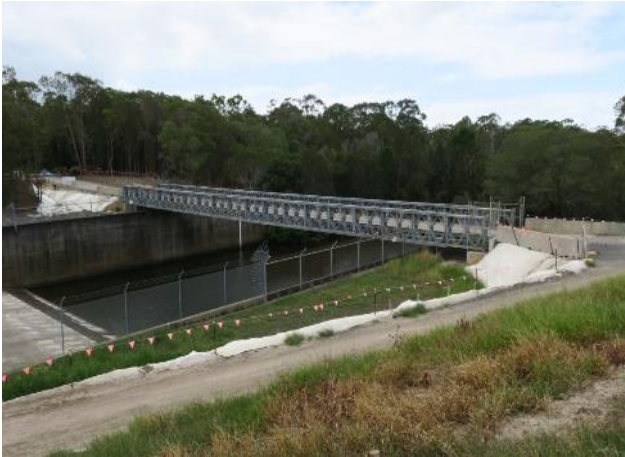
Figure 9 - Temporary access bridge over spillway

On any construction project, plant and heavy vehicle access is a critical factor in productivity. Due to the dam's location within a suburban area (the nearest houses downstream are only 300 m from the dam), access routes were investigated thoroughly by giving due consideration to the associated benefits and drawbacks of each potential route. The preferred option involved crossing Tingalpa Creek downstream of the spillway chute and a concept design was prepared for a dumped rock/earthfill causeway. The Contractor proposed an alternative design, which made use of a temporary bridge directly

over the spillway dissipater (Figure 9). This was subsequently accepted by Seqwater and proved to be a critical link in the success of the project. The lessons learned from this experience are as follows:

- Temporary, steel truss bridges are a feasible alternative to dumped rock/earthfill causeways for access over spillway chutes;
- Single spans of 50-60 m are achievable for heavy vehicle (T44 loading) movements;
- Piled abutments constructed within close proximity to spillway walls (< 10 m) are possible;
- Keeping heavy vehicles off suburban streets is a significant risk reduction and community benefit for large construction projects.

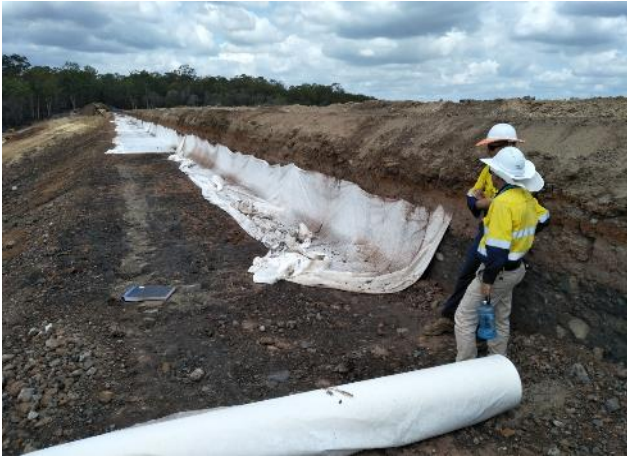
Figure 10 - Granular materials uncovered at crest

- Tree roots in foundations and/or embankments;
- Oversize material (e.g. boulders) in foundations and/or existing embankments;
- Foreign matter (e.g. asbestos, waste, quarry remnants) in foundations and/or embankments;
- Loose and/or saturated materials in existing embankments;
- Granular materials in existing embankments (Figure 10);
- Low plasticity clay in the dam core.

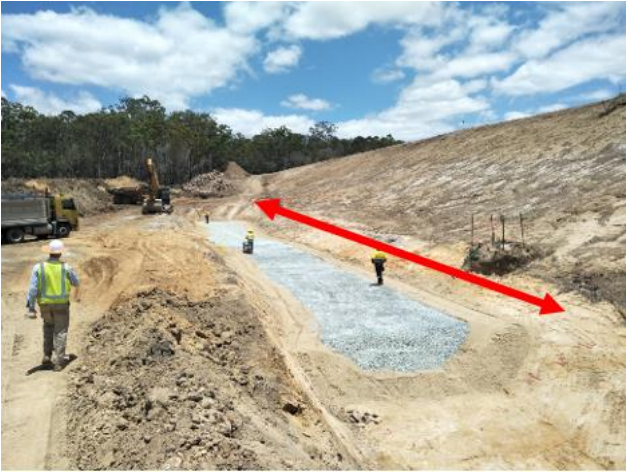
Figure 11 - Work front panel width

For dam safety during construction, downstream earthworks operations are often limited to a specified panel width (Figure 11). However, what is technically possible, what the Contractor deems necessary and what the dam owner is comfortable with, may not be congruent. There is a balance that needs to be achieved between opening up a work front that is acceptable in terms of dam safety, what gives the Contractor sufficient flexibility and what is palatable for the dam owner. This should be considered at the design stage for a range of conditions, and incorporated into construction specifications. Specifically:
