Evaluation of marginally non-compliant dam filter materials using the No-Erosion Filter test method

This paper presents the methods, observations and results from a programme of No-Erosion Filter (NEF) testing for the evaluation of a manufactured filter aggregate product that did not conform to normally accepted D_{15F} grading limits. Base materials tested include both dispersive and non-dispersive soils. The results are compared against published no-erosion, excessive erosion and continuing erosion thresholds. The paper comments on the validity of the adopted thresholds and the effectiveness of the NEF test as a filter evaluation method.

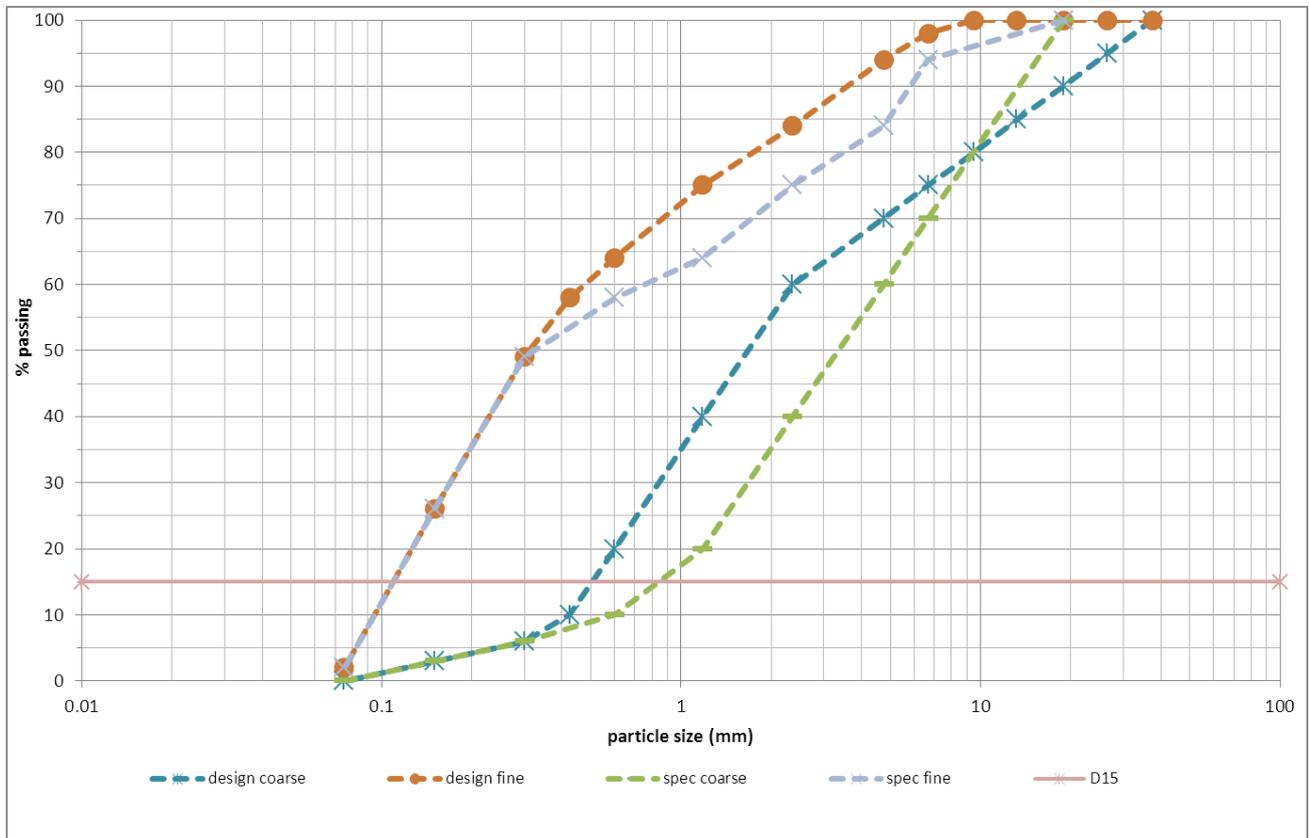
Figure 1: Design and specification grading envelopes

Following extensive field and laboratory investigations and desktop work a suitable filter material was specified. Unfortunately an error was made while transposing data from the graph to the table in the design report. This was then transferred to the technical specification issued for the project. Table 1 presents the design and specification gradings and these are presented graphically in Figure 1.

The design grading, would have met the no-erosion (Fell *et al.* 2005) grading criterion of D_{15Fmax} of 0.5mm for dispersive category 2A base soils. However, the D_{15Fmax} for the specification grading was approximately 0.85mm.

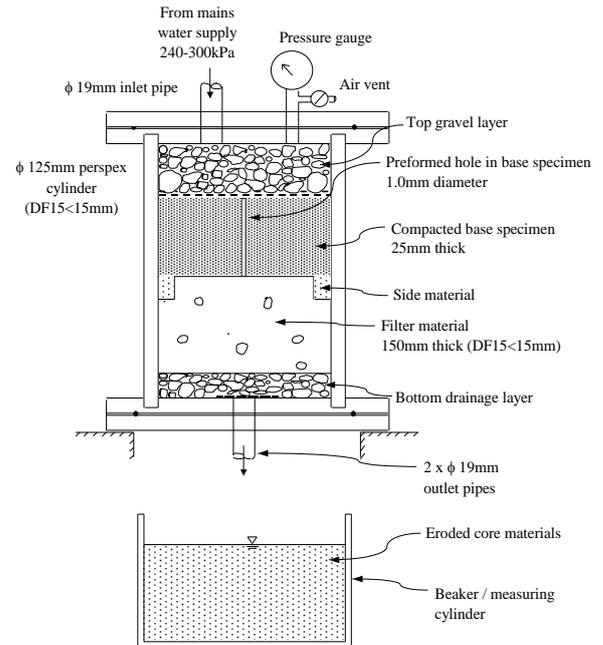
Figure 2 – No-erosion test apparatus (Sherard and Dunnigan, 1989)

The NEF testing was performed in a Sydney based soils laboratory. The NEF test used is based on procedures described by Sherard and Dunnigan (1989). The Sherard and Dunnigan test apparatus is illustrated in Figure 2. The test evaluates the effectiveness of the filter zone to stop erosion from a concentrated leak through the base soil from the embankment core should a concentrated leak form along a crack or poorly compacted zone.

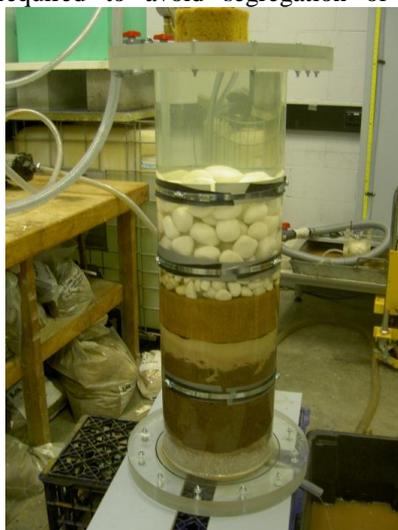
293mm NEF Test

Figure 3 Coarse grained filter (293mm) and fine grained filter (125mm) NEF test apparatus

The test apparatus used is a 125 mm diameter Perspex cylinder for fine grained filters or a 293 mm cylinder for coarse grained filters.

The coarse and fine grained filter test apparatus are shown in Figure 3.

When using the 293mm Perspex cylinder, banding of the cylinder is required to reduce side wall flex which can allow side drainage and cylinder failure. A hole of 5mm diameter is used in order to reduce the likelihood of gravel blocking the exit. It also assists to increase the amount of eroded material which can be captured by the filter. The size and weight of the 293mm x 1000mm high cylinder requires the preparation and handling methods to be modified.

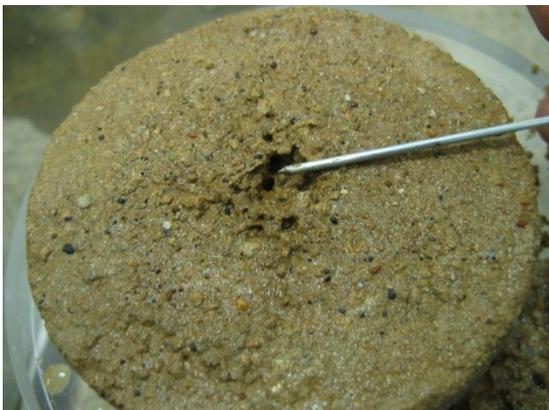
Base of clay core after test

Figure 4 – Post NEF test observations

The test is normally let run for at least 60 minutes depending upon filter performance. Flow rate measurements, colour and post-test observations are recorded as per Sherard and Dunnigan (refer Figure 4).

Specific attention is given to the colour of the filter directly underneath the clay core and the hole shape in the clay core. Extrusion is performed by inverting the cylinder on a suitable frame and slicing away the layers until the clay core is exposed

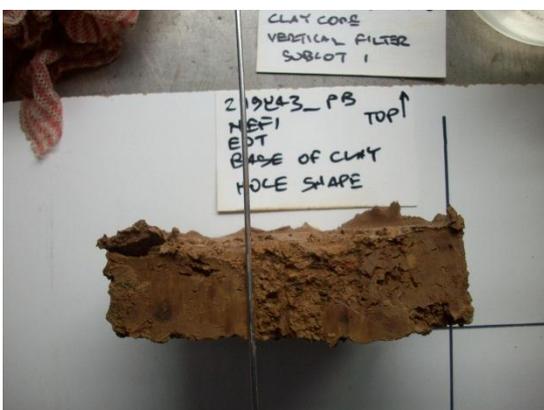
Eroded hole after test

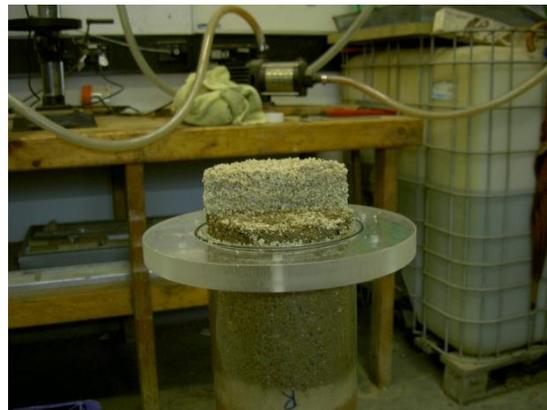
After test extrusion

Figure 4 – Post NEF test observations (continued)

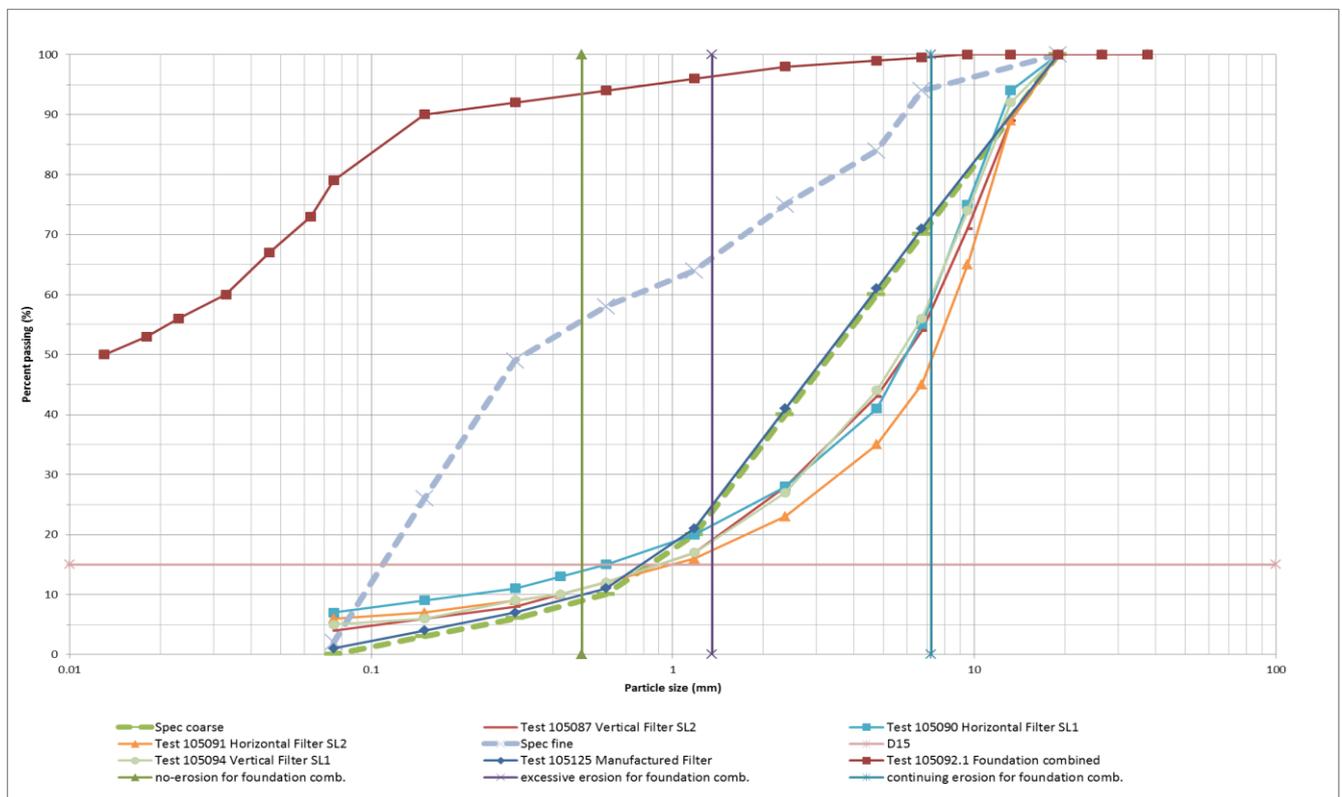
Figure 5 Filter grading results compared against the specification

The foundation soil from Chainage 460 was identified as the most dispersive of all base materials tested (Emerson Class 1 in distilled water, Emerson Class 2 in Sydney tap water and Pinhole Dispersion Class D2). The grading for the foundation base soil is shown in Figure 5.

The grading of the site sampled filter materials and the manufactured filter with reference to the specification is presented in Figure 5.
