Root Cause Analysis (RCA) in Dam Design

Malcolm Barker

Principal Engineer Dams, GHD

This paper will present the use of Root Cause Analysis (RCA) as a means of evaluating the causes for failure modes and is based on work completed for an upstream tailings storage facility (TSF) raise where significant transverse and longitudinal cracking was observed.

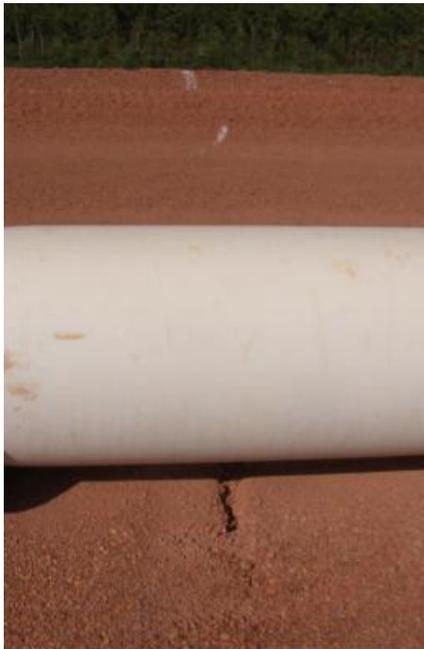
Photographs of typical transverse cracks and a test pit are shown on Figure 5. The transverse and longitudinal cracks were found to intersect at some locations, as shown on Figure 6.

Figure 5 – Transverse and longitudinal cracking observed on the Stage 1 upstream raise

Transverse Crack on Crest

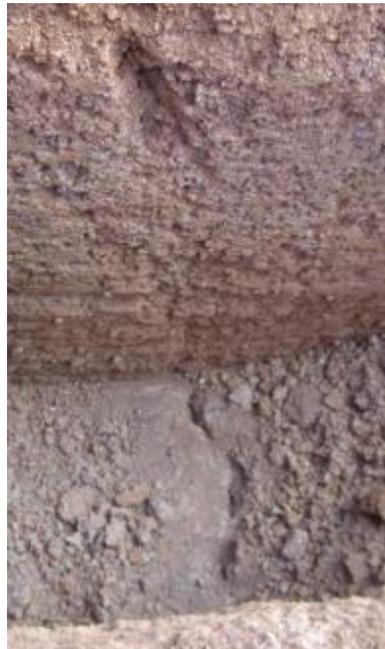
Test pit for transverse crack

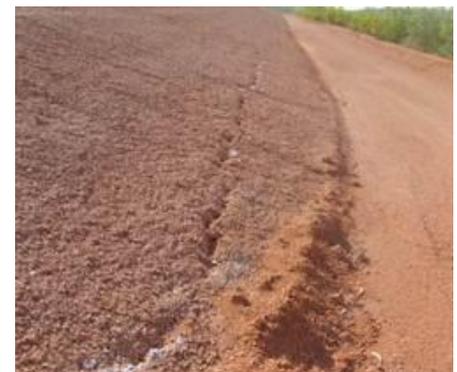
Longitudinal crack at downstream side of raise
