An unusual tunnel collapse, the Hull Wastewater Transfer Tunnel

Australian Tunnelling Society

Wednesday, 26th March, 2014

Steve Macklin | Principal Tunnel Engineer/
Engineering Geologist, GHD Melbourne

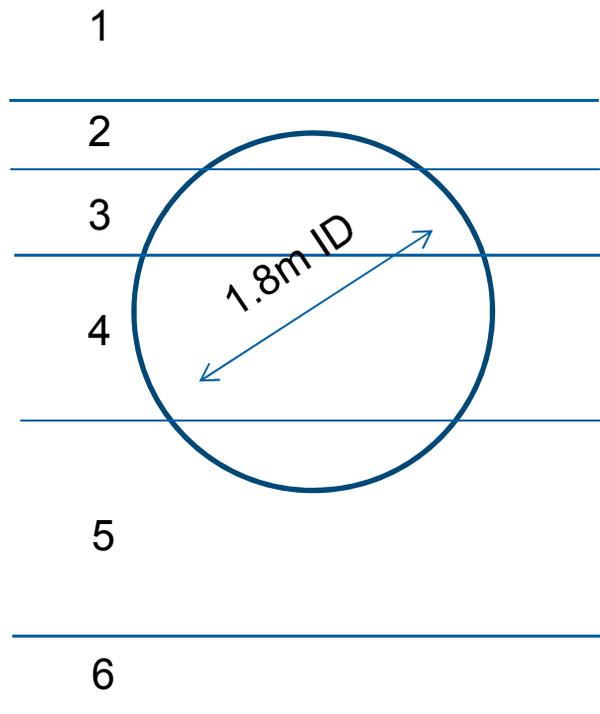
1. Medium dense silty, fine to medium alluvial **SAND** (non-tidal aquifer)
2. Firm to stiff and friable **PEATY CLAY/SILT**, with fragments of timber, aquitard, $k_h \leq 400k_v$
3. Upper alluvial **SILTY FINE SAND** grading down to **GRAVELLY SAND** to **SANDY GRAVEL**

4. Soft to firm to stiff thinly **LAMINATED CLAY** (aquiclude, $k_h \leq 10k_v$)
5. Dense fine **AEOLIAN SAND**
6. glacial **SAND AND GRAVEL** (tidal aquifer)
