**North American Society for Trenchless Technology (NASTT)
NASTT's 2015 No-Dig Show**

Paper MM-T1-05

Questions Answered By NDT Inspection for Forcemains in Service

Dwayne Hofstetter, Conestoga-Rovers & Associates, Waterloo, Ontario
Brad Marin, Conestoga-Rovers & Associates, Waterloo, Ontario

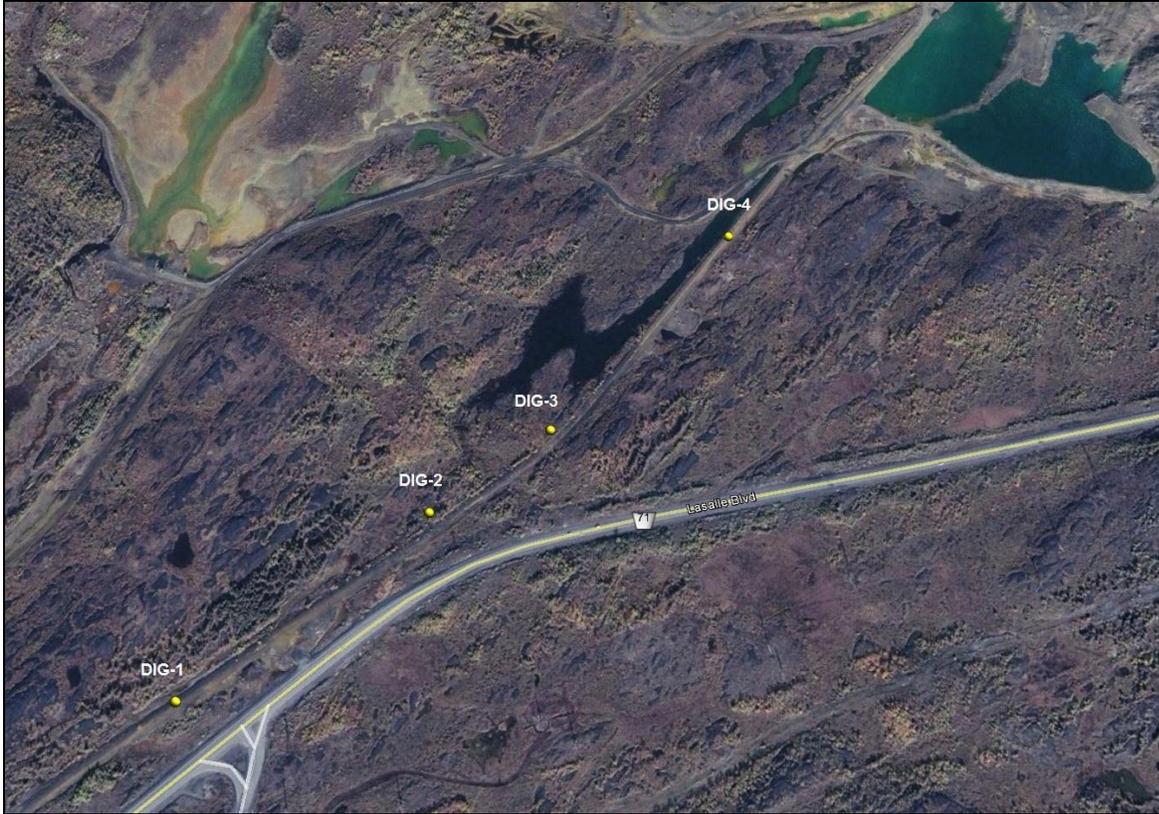
Figure 2. Test Site Locations

A review of the existing conditions drawings indicated four key locations of sags, crests, and/or horizontal/vertical bends within the 1.6 km (1 mile) test section that was to be observed. These areas are indicated on Figure 2.

AUT scanning was completed for each of the four excavation locations, and an area of the full circumference by 600mm (2 feet) length was examined by means of automated thickness measurements (Figure 2. Test Site Locations).

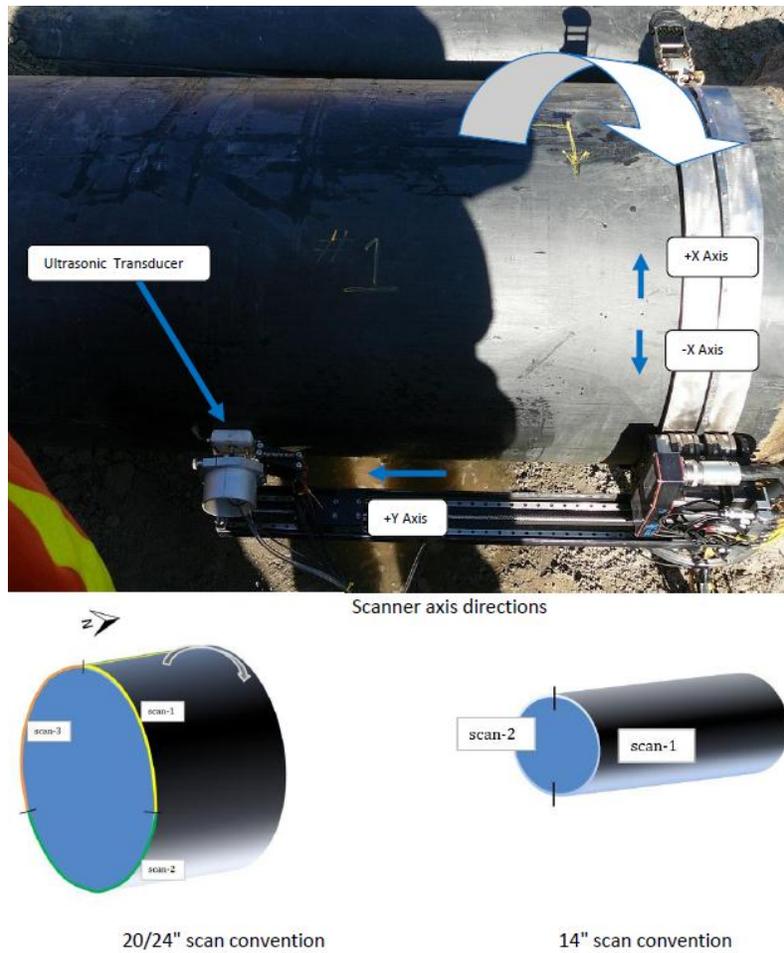
The AUT scanner operates on a two-axis system: X and Y. The Y-axis runs axially on the scanner arm while the X-axis runs circumferentially, utilizing its magnetic wheels. Once a stroke is complete on the Y-axis, the X-axis will index over and another Y-axis stroke will begin. Indexing increments are based on project requirements. For full volumetric coverage, indexing increments will be smaller than the transducer crystal diameter to insure an overlap in ultrasonic coverage. See Figure 3. AUT Scanning

The transducer is then placed at the 12 o'clock position to begin reading. It then moves back and forth along the carriage to create the banding information of depth for the test section.

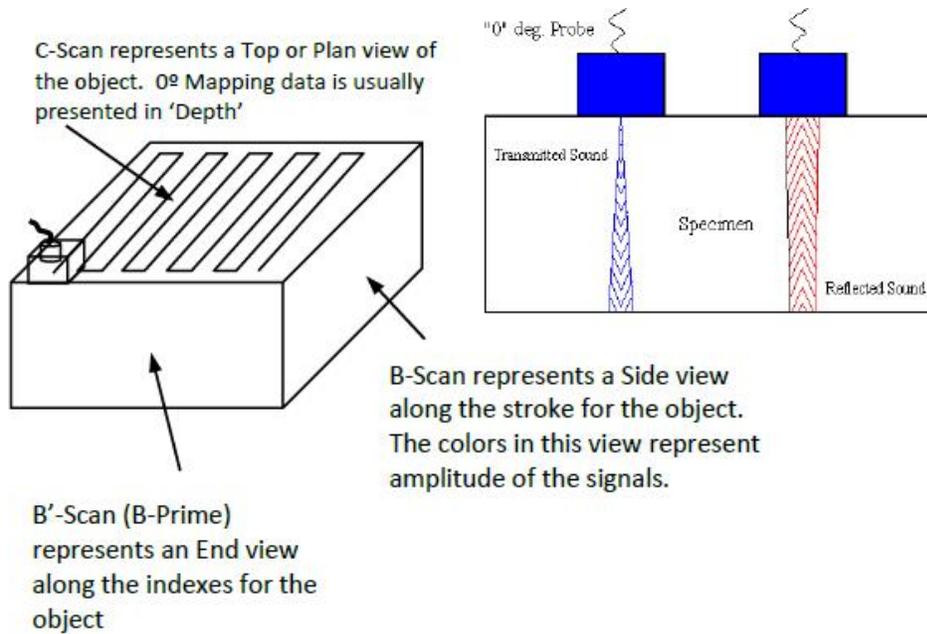
Figure 4. AUT Scanning View

The test results then are recorded in a color pallet indicating the depth/thickness of the pipe, starting at the 12 o'clock position, or in our case, 0 degrees.
