Kangaroo Creek Dam Embankment Raising and Stabilisation – Balancing Competing Objectives

Peter Buchanan¹, Malcolm Barker¹, Paul Maisano¹, Marius Jonker²

1. GHD Pty Ltd Principal Engineers 2. Consultant

Kangaroo Creek Dam located on the Torrens River, approximately 22 km north east of Adelaide, is currently undergoing a major upgrade to address a number of deficiencies, including increasing flood capacity and reducing its vulnerability to major seismic loading.

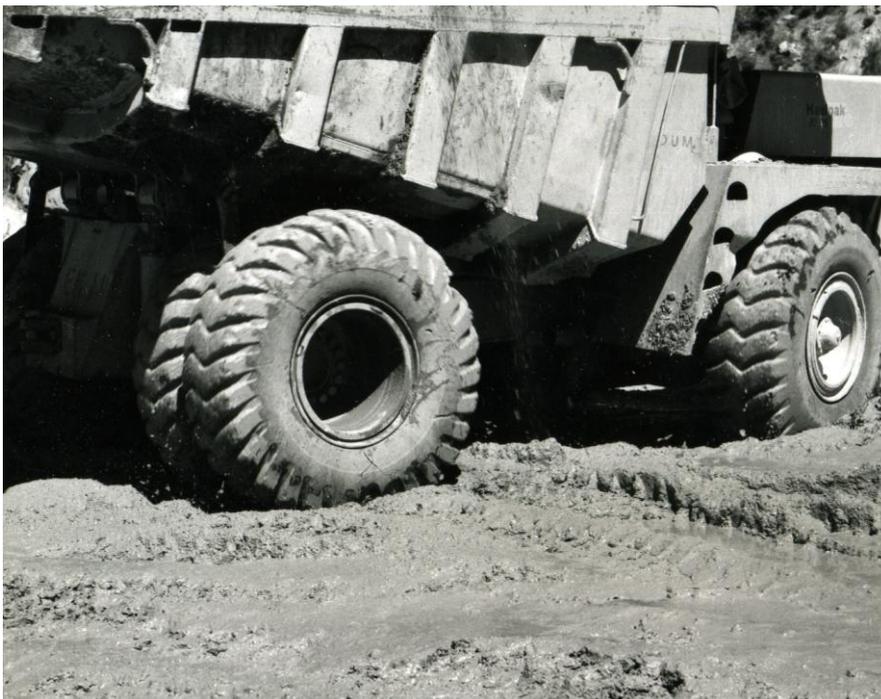
Figure 3 – Breaking down of the upper surface of a lift due to the trafficking and sluicing (photo courtesy of SA Water)

Much of the spillway excavation consisted of low strength, moderately to slightly weathered schist and gneiss, which had a tendency to break down when worked. In all the zones, and in particular Zones 2 and 3, there was a tendency for the rockfill to break down during the sluicing and compacting, resulting in “skins” being formed on the top of each compacted layer (refer Figure 2 and Figure 3).

Furthermore, the available construction records indicate that much of this fine material is concentrated on the top of each layer, as the material was broken down during the compaction process. This can be seen in Figures 2 and 3 where the combination of compaction loading and sluicing water have resulted in the rockfill breaking down to a “soil like” material forming a “skin” on the top of each lift. The extent to which these “skins” formed was dependent on the amount of finer material transported to the embankment, the proportion of weak rock in the material, and the amount and type of traffic over the fill. It is reported in construction records that these skins are typically 50 to 150 mm thick, although up to 500 mm thick in locations (Trudinger 1973). This has resulted in an anisotropic fill with the upper part of the layers consisting of finer material controlling the vertical permeability and the cleaner, less broken down in the lower part of the layer controlling the horizontal permeability of the layer. Furthermore, these “skins” are of such a depth that it is possible that there may not be rock to rock contact between lifts.
