VINGT CINQUIÈME CONGRÈS
DES GRANDS BARRAGES
STAVANGER, JUIN, 2015

USE OF RISK ANALYSIS FOR TAILINGS STORAGE FACILITY UPGRADE*

Malcolm BARKER
Principal Engineer Dams, GHD Brisbane

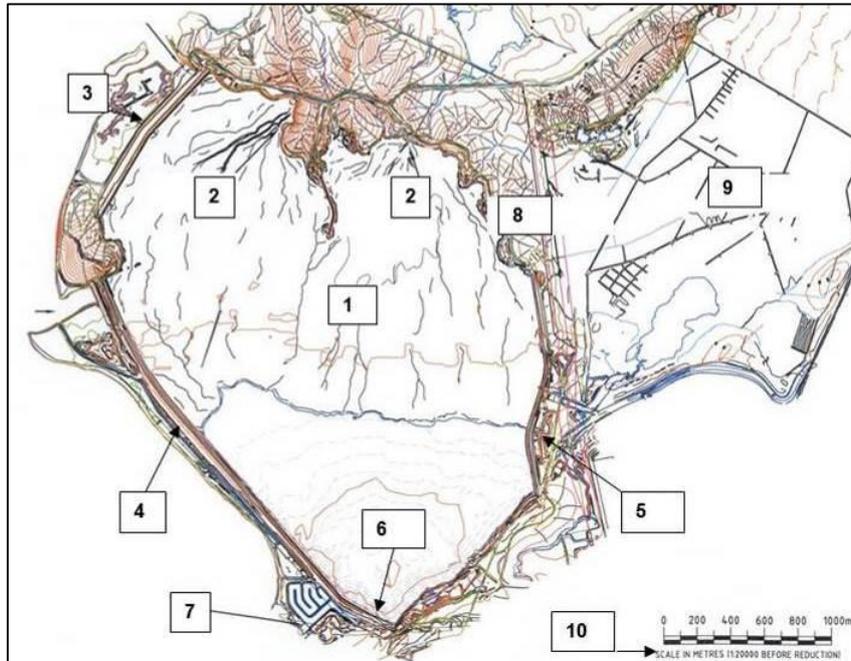
Fig. 2
Schematic layout of RMD2
Shéma du RMD2

The components of RMD2 are shown on Fig 2. The dam embankments, which generally comprise Zone 1 clay core with Zone 3 outer shells constructed over rock foundation. Geofabric was provided between Zone 1 and 3 on the upstream side and a downstream filter for piping protection was provided on the lower section for all embankments and to the crest for Dam A/C and part of Dam D.

1	Red Mud Dam 2	1	<i>Barrage de boue rouge 2 (RMD 2)</i>
2	Discharge Point	2	<i>point de rejet</i>
3	Dam D	3	<i>Barrage D</i>
4	Dam A/C	4	<i>Barrage A et C</i>
5	Dam E	5	<i>Barrage E</i>
6	Spillway & Outlet Works	6	<i>Deversoir et point de sortie</i>
7	Overflow and Labyrinth	7	<i>trops-plein et labyrinthe</i>
8	Water and power easement	8	<i>accès en eau et energie</i>
9	Red Mud Dam 1	9	<i>Barrage de boue rouge 1</i>
10	Scale before reduction	10	<i>échelle avant reduction</i>

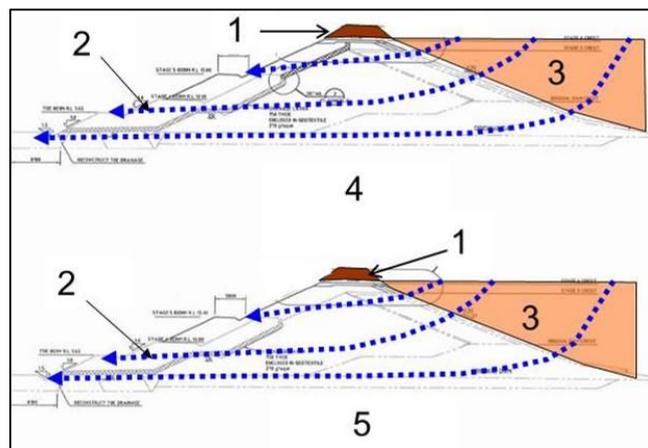
Fig. 3

Dam A/C and part Dam E typical failure pathways
Model de rupture classique de digue A,C et partiellement E

1	1 m raise	1	<i>rehausse de 1 m</i>
2	Failure Pathways	2	<i>direction des ruptures</i>
3	Red Mud	3	<i>boue rouge</i>
4	Dam A Chg 260 m to 1370 m and Dam E	4	<i>Barrage A de 260 m á 1370 m, et barrage E</i>
5	Dam A 1370 m to 2207 m and Dam C	5	<i>Barrage A de 1370 m á 2207 m et barrage C</i>

Geosynthetic Clay Liner (GCL) was provided upstream in some embankments for seepage and piping control. Typical embankment zones are shown on the failure modes (Fig 3). In addition to the internal zoning, cement stabilised tailings was constructed upstream of Dam D for about 25 m with a depth of about 3.5 m for the upstream raise construction. This cement stabilised fill is expected to preclude the piping failure modes through the upper part of the embankment.

- Screening of Initiating Events
 - A list of potential failure initiating events was developed and screened to remove those events that were considered to be unlikely to affect the safety of the tailings dams.
- Component Definition
 - The RMD2 was considered to be the main system with sub-components comprising the spillway and outlet works and Dams A/C, D and E.
- The primary and auxiliary function of each component was defined.
- Failure Modes Analysis (FMA)
 - A FMA was performed to determine the causes or mechanisms of failure from which the failure modes for further analysis were determined using the knowledge of the various components and their behaviour under each hazard or initiating event. All failure modes were screened for acceptance or rejection for further analysis. Typical piping failure pathways are shown on Fig 3.

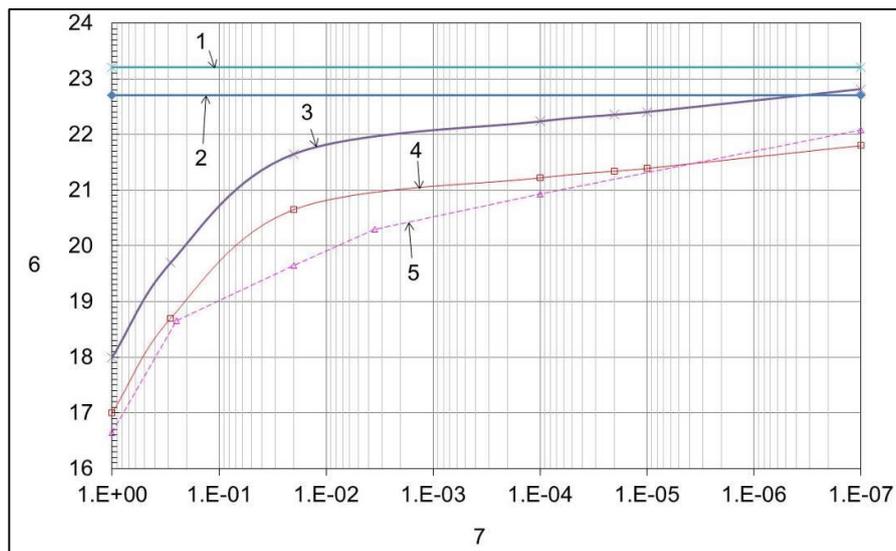
Fig. 4

The rating curve for the labyrinth spillway was used for floodrouting the inflow floods from the 1 in 50 AEP event to the Probable Maximum Design Flood (PMP-DF) (Fig 4).

QAL RMD2 Stage 6 to 8 Water Level versus Annual Exceedance Probability AEP

Dam A/C and Dam E will be raised to RL 22.7 m and include a 0.5 m high safety bund on the upstream and downstream edge of the crest. Dam D will be raised to RL 24.0 m using a general fill section placed onto the cement treated red mud (Fig 4). The labyrinth spillway will be raised from RL 20.65 m to RL 21.65 m.

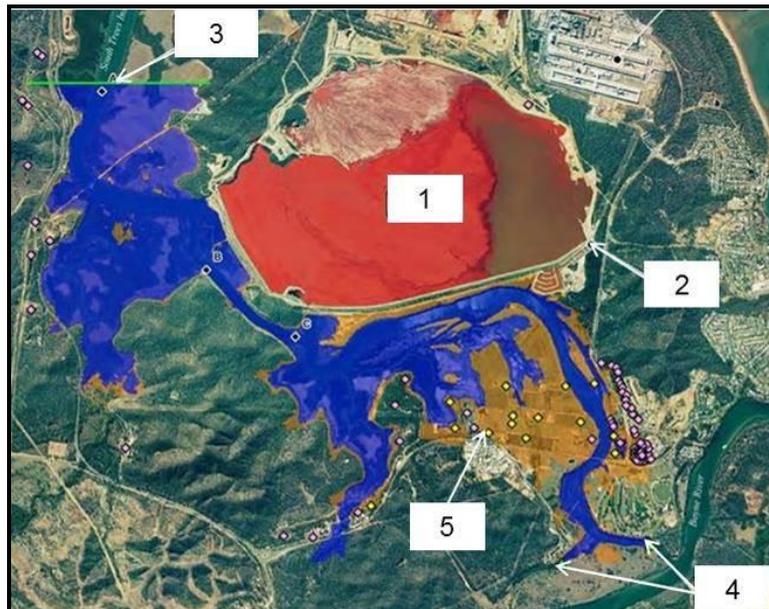
Fig. 7

The potential Population at Risk (PAR) and life loss was made for breaching of the Dam E towards the north and Dams A/C and D to the South. Breach analyses were completed for the Sunny Day failure and PMP-DF from which the remaining events were evaluated for the risk estimation. The Inundation mapping for the PMP-DF breach of Dam A/C is shown on Fig 7 where

the 1 in 100 AEP flood extent is shown in blue and the PMP-DF is shown in brown.

PMP-DF breach failure for Dam A/C
