**North American Society for Trenchless Technology (NASTT)
NASTT's 2015 No-Dig Show**

Paper TA-T6-02

Cast-In-Place Pipe Watermain Rehabilitation – What It's All About

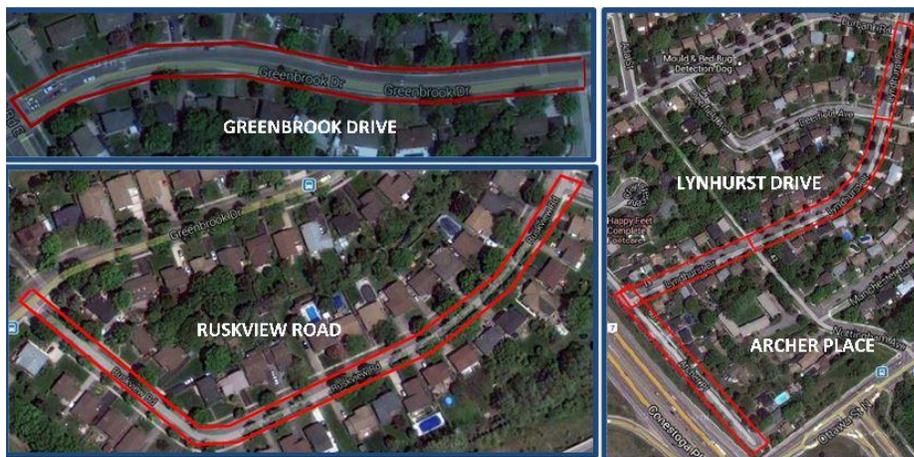
Figure 2 Watermain Locations

Location of Defective Watermain	Limit of Watermain Extent	Original Installation Year	Diameter of Watermain	Existing Watermain Material	Length
Greenbrook Dr	Westmount Rd East to Farmbrook Pl	1957	200 mm (8 in.)	Cast Iron	278 m (912 ft)
Lyndhurst Dr	Archer Pl to Burbank Rd	1958	150 mm (6 in.)	Cast Iron	456 m (1496 ft)
Archer Pl	Ottawa St North to Lyndhurst Dr	1962	150 mm (6 in.)	Cast Iron	223 m (731 ft)
Ruskview Rd	Sweetbriar Dr to Greenbrook Dr	1963	150 mm (6 in.)	Cast Iron	372 m (1220 ft)
